# City of Ponderay, Idaho

## Stormwater Masterplan Report and Recommendations

Submitted: May 16, 2005

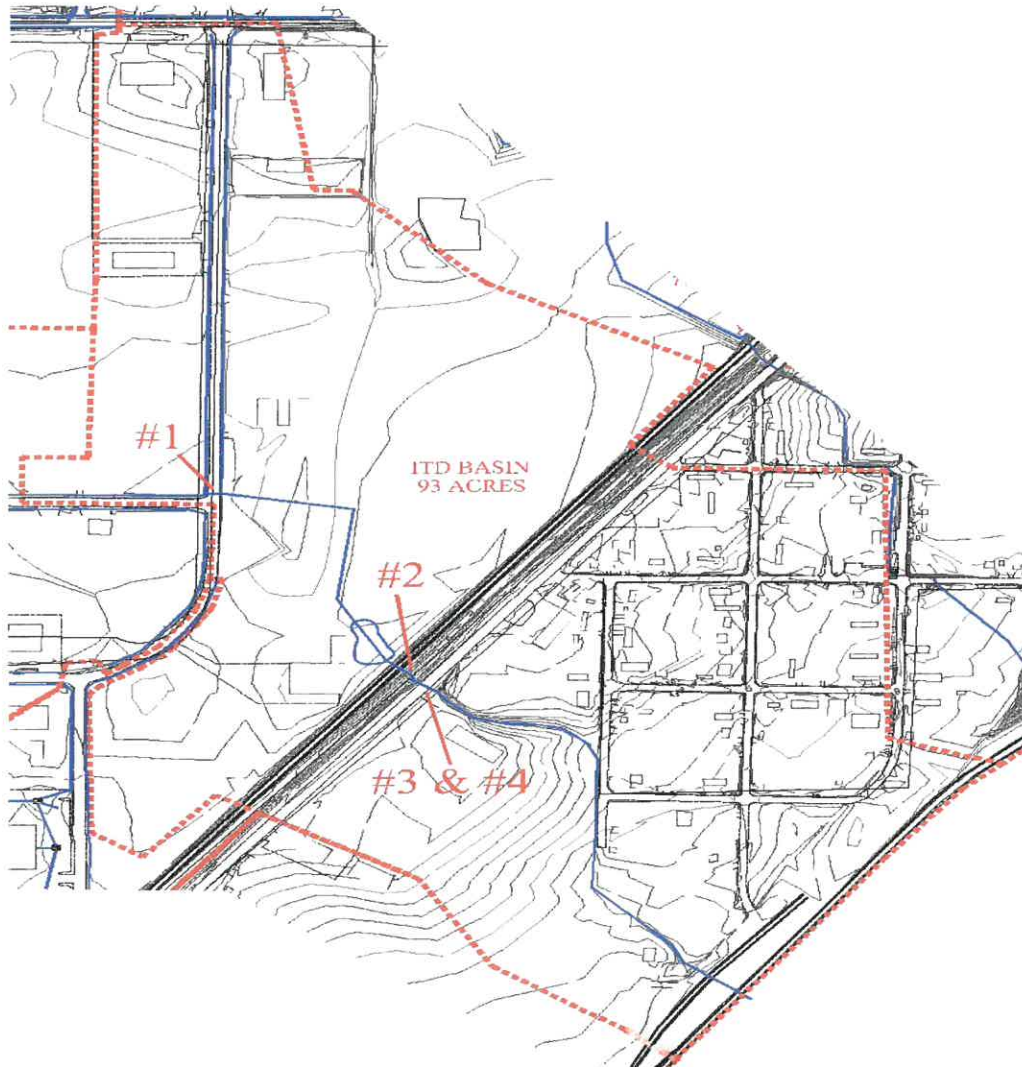
## ITD Basin

The ITD Basin is approximately 93 acres in size, and extends southeast from Triangle Drive to the outfall at the lake. Culvert 1 at Triangle Drive is 12" in diameter and has a damaged inlet. The culvert is undersized for the simulated event when the land becomes developed in the future. At this time, the estimated peak flow will be 3 cfs, which is well over the current 1.5 cfs capacity of the pipe. This will cause flooding of the ditch lines and saturation of the road base. The flow moves from culvert 1 into an open channel and downstream into a shallow detention area at the inlet of culvert 2. It would be beneficial to increase the capacity of this pond and upstream channel to provide additional treatment and storage. If the land is developed and this storage capacity removed, the downstream culverts (2-6) would all need to be enlarged. As it is, culverts 2-6 are all near capacity for the simulated storm after full land development has occurred. The drainage continues under the UPRR tracks and HWY 200 into a channel alongside the ITD offices. The channel has accumulated an excessive amount of sediment, causing adverse outlet conditions for culverts 3 and 4.

ITD Basin - Recommendations for Culvert 1 (3 options):

Replace culvert 1 with a pipe arch capable of passing 3 cfs. From the Handbook of Steel Drainage and Highway Construction Products (Table 3.15) a 17 x 13 arch would be adequate for the flow.

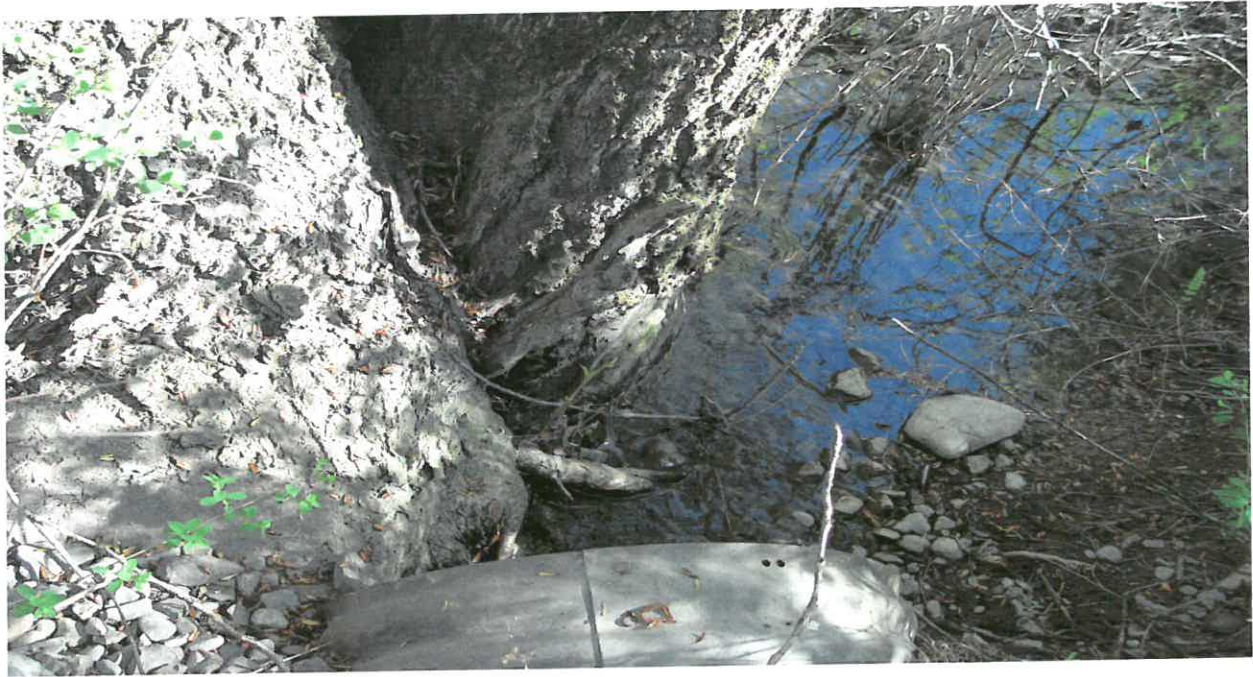
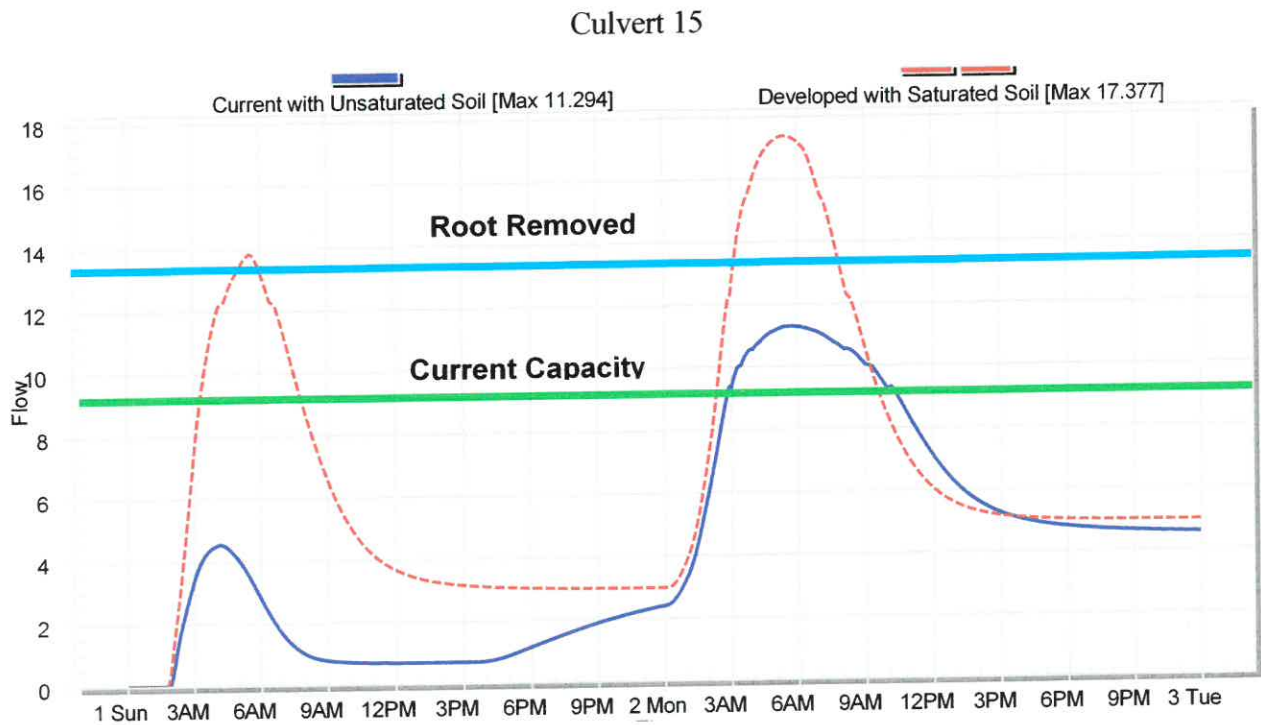
McNearney Road Basin - Recommendations for Culvert 15

#2: Flooding of the woodlands north of the UPRR tracks at culvert 15.

- Remove the tree from the outlet of the culvert. This would increase the capacity by 50% and reduce the flooding north of the tracks.

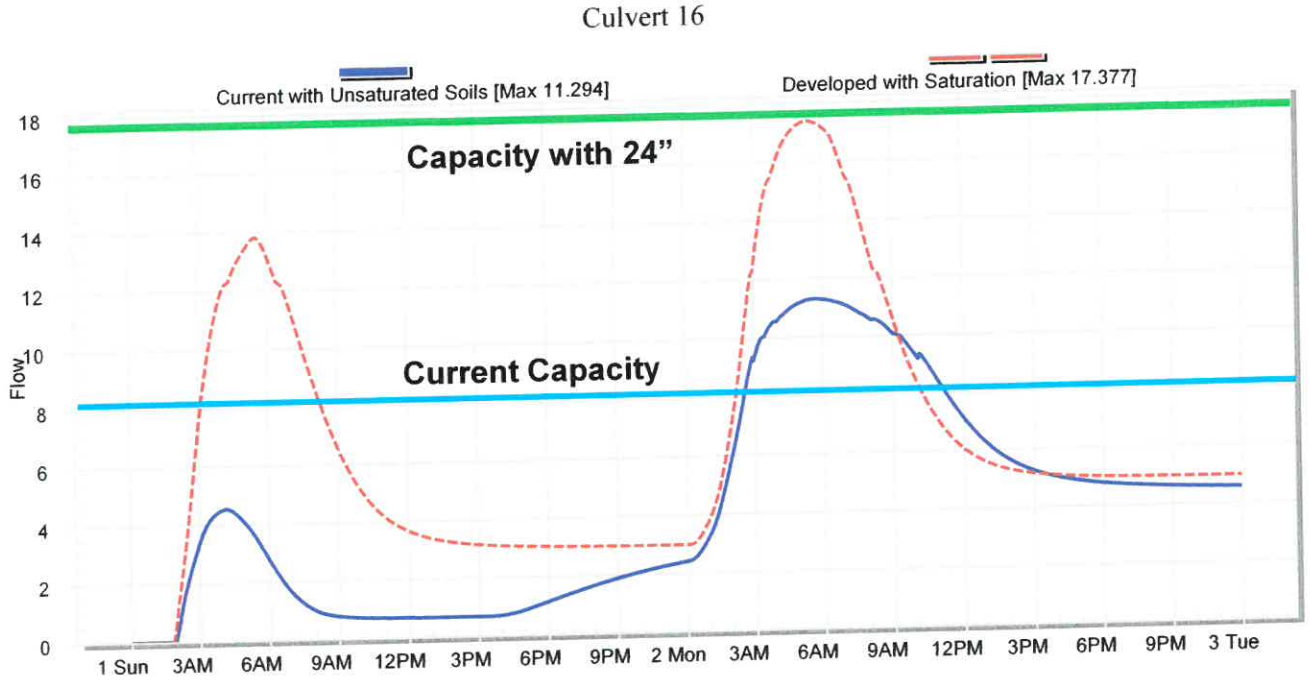
McNearney Road Basin - Recommendations for Culvert 16

**#3:** Flooding of road base along HWY 200 at culvert 16.

- Replace with a 24” culvert (or equivalent arch) to accommodate the increased flows from culvert 15 and reduce the flooding along HWY 200.

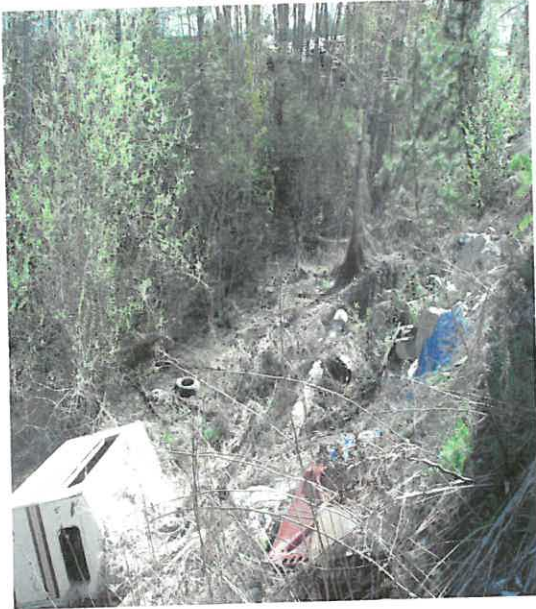
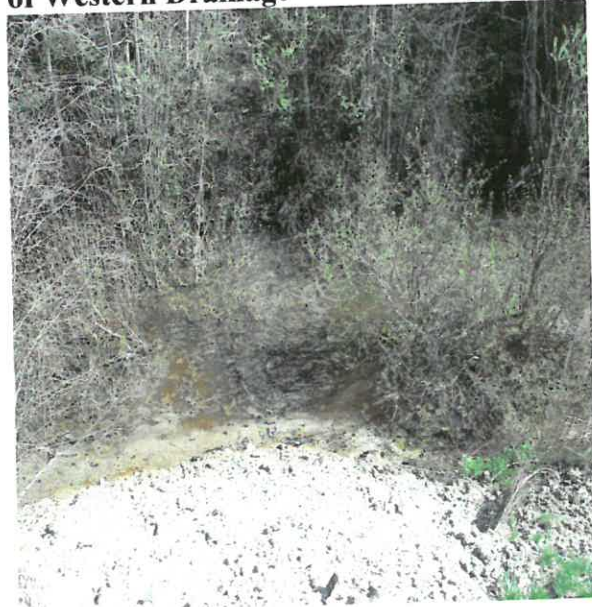
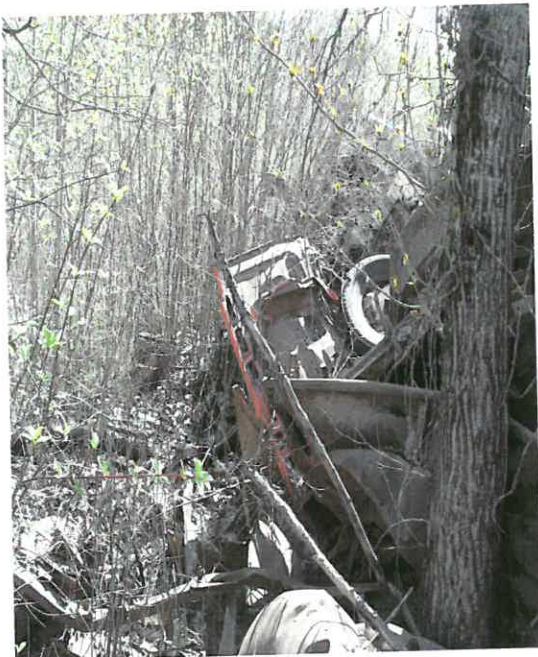
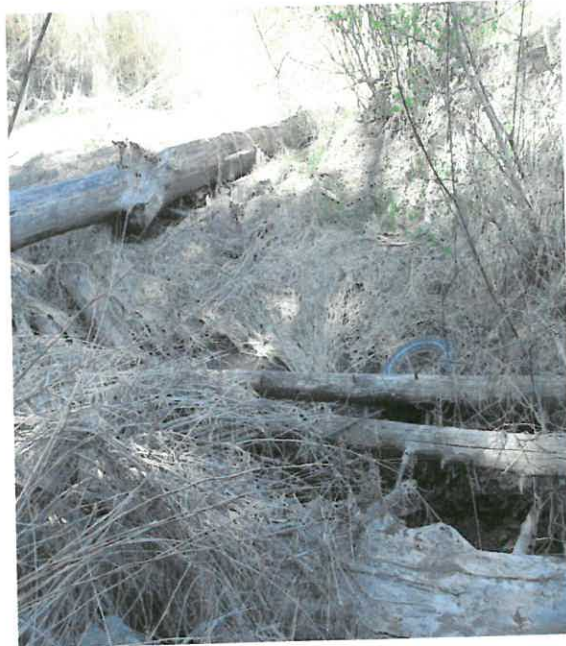
**Current Condition of Western Drainage**

The culverts in the western drainage have adequate capacity, and will be able to handle the flows generated from future land development. However, the drainage channels and wetlands south and east of HWY 200 are in poor condition. A combination of garbage, loose fill dirt, and excessive debris pollute the waterway and prevent natural wetland processes from occurring. In addition, unstable channels lead to erosion and sedimentation of the runoff.

**#1:** The western drainage channel between Dads Auto and Anderson Autobody and the associated wetlands have been degraded with automotive parts, tires, loose fill dirt, and excessive brush and other debris.

- Drainage channels and wetlands need to be cleaned and stabilized with rock and stream grade control structures to reduce velocity and minimize erosion.

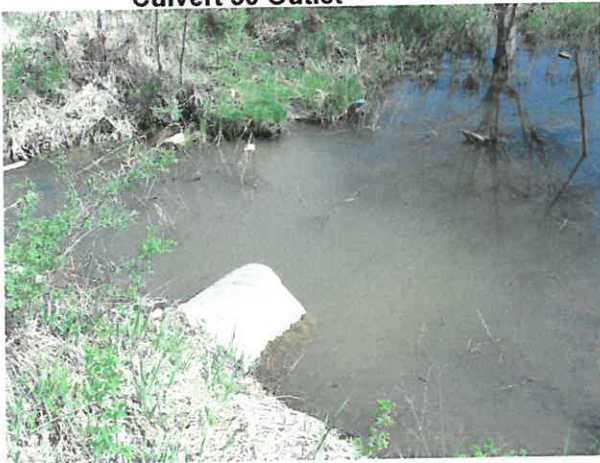
**Culvert 30 Outlet**

The eastern drainage has several areas that need improvement. First, culvert 30 (30" dia) under the UPRR tracks has an outlet set 2 feet below the elevation of the downstream channel. This creates adverse outlet conditions, and reduces the capacity of the culvert from about 30 cfs to 9 cfs. The reduced capacity causes flooding of the trailer park and areas on the north side of the tracks. Second, culvert 31 (36" dia) passing under HWY 200 has been shown both by observation and in the model to have severe flooding at the upstream end. Theoretically, the culvert should pass the 25 cfs flow that results from the design storm. However, an inspection of the culvert reveals a low point in the middle of the highway, sediment buildup at the outlet, and a constriction in the downstream channel. These conditions reduce the culvert capacity from 35 cfs to approximately 14 cfs. Third, the channel immediately downstream of culvert 31 is undersized and has two 90 degree bends that create turbulent flows and excessive erosion. The remainder of the drainage south of HWY 200 has debris buildup and a highly erodeable channel. The grate on the vertical pipe inlet of culvert 37 (48" dia) was found to be plugged with debris.

**#2:** Flooding of the trailer park to the west of culvert 30.

- Raise the outlet of culvert 30 by 2 feet in order to increase the capacity of the culvert to 30 cfs (currently 4' fall from inlet to outlet).

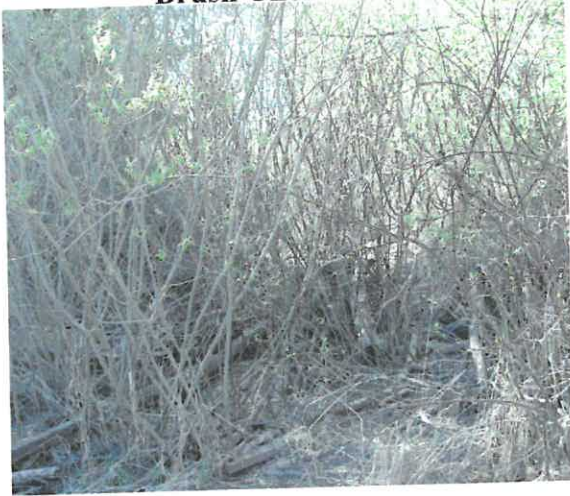
**Brush Choked Channel**

**#4:** Overtopping and excessive velocity and erosion in drainage channel south of culvert 31.

- Improvements upstream will lead to increased peak flows. Debris buildup and other obstructions should be removed to facilitate efficient flow and allow adjacent properties to drain properly.

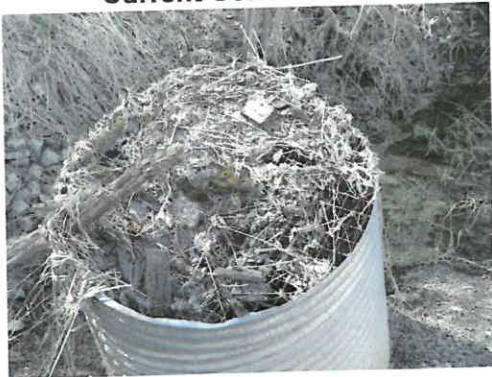
**Current Condition**

**#5:** The grate on the vertical inlet of culvert 37 plugs with debris, and could fail in the future.

- Replace flat grate with a peaked grate similar to the grate at culvert 38.

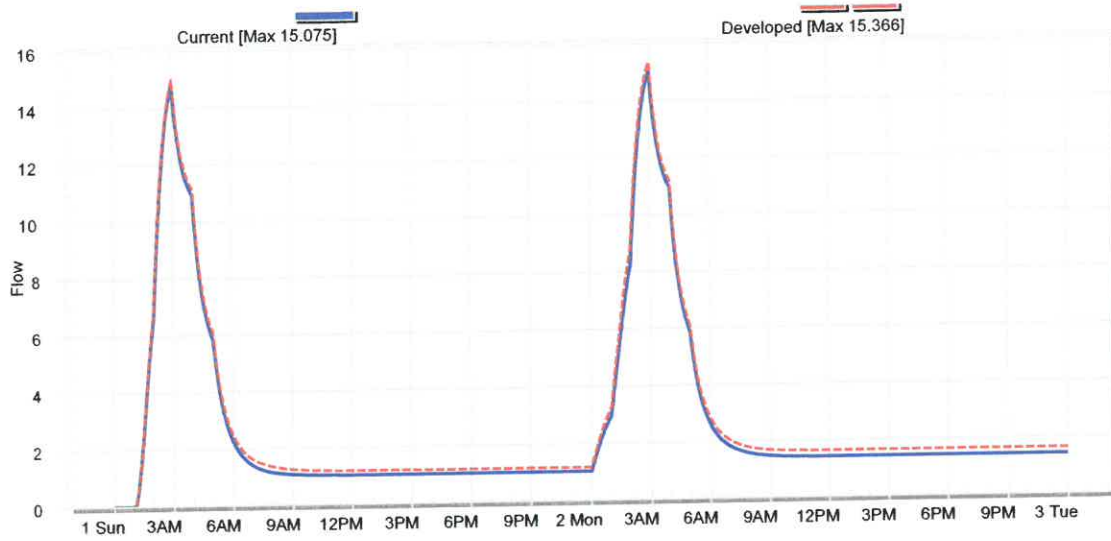
### Bonner Mall Basin Outfall

**#3:** Sediment and debris buildup.

- Clean the wetland east of Fontaine Drive to restore capacity.
- Remove sediment from the catchbasins associated with the Bonner Mall Complex.

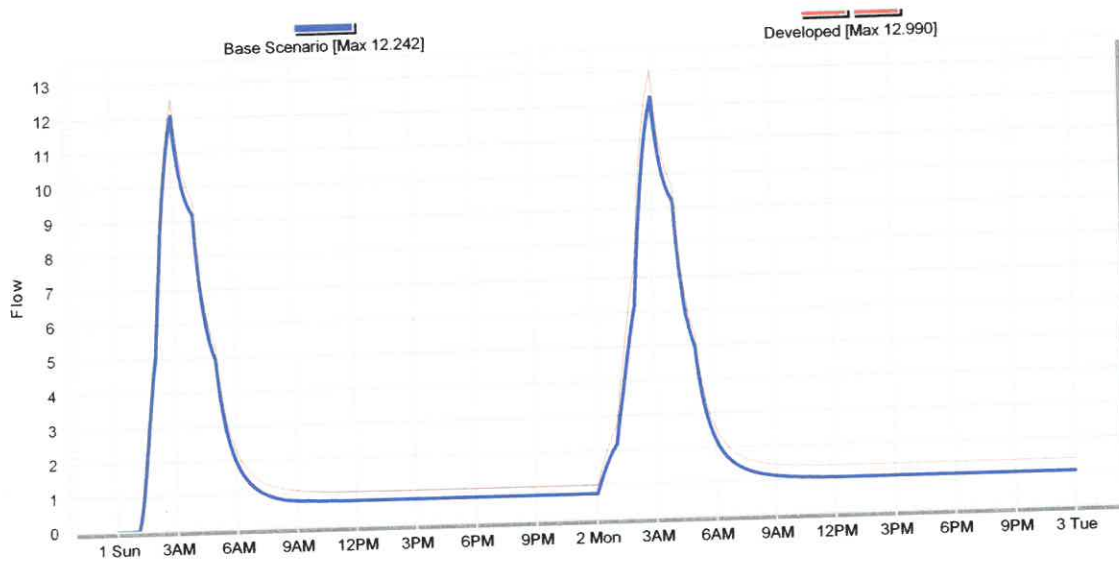
### Outfall from Schweitzer Plaza Basin

The Schweitzer Plaza Drive Basin is approximately 48 acres in size, and flows west from Triangle Drive and across HWY 95 before entering Sand Creek. The culverts have adequate capacity for the design storm, but the ditch lines along Triangle Drive and Schweitzer Plaza Drive are too shallow, narrow, and have a minimal slope. Consequently, the road base is saturated throughout the wet months and the paved roads are rapidly deteriorating.

#1: Roadway degradation caused by standing water in the shallow ditch lines.

Enlarge and deepen existing ditch lines to create grassy swales that will provide treatment and reduce saturation of the road base.
