RE: DRAFT Geotechnical Evaluation
Ponderay Hotel Development
Parcel # RPP00000037302A
Ponderay, Idaho
ALLWEST Project No. 121-360G

**DRAFT GEOTECHNICAL EVALUATION
PONDERAY HOTEL DEVELOPMENT
PARCEL # RPP00000037302A
PONDERAY, IDAHO
ALLWEST PROJECT NO. 121-360G**

**DRAFT GEOTECHNICAL EVALUATION
PONDERAY HOTEL DEVELOPMENT
PARCEL # RPP00000037302A
PONDERAY, IDAHO**

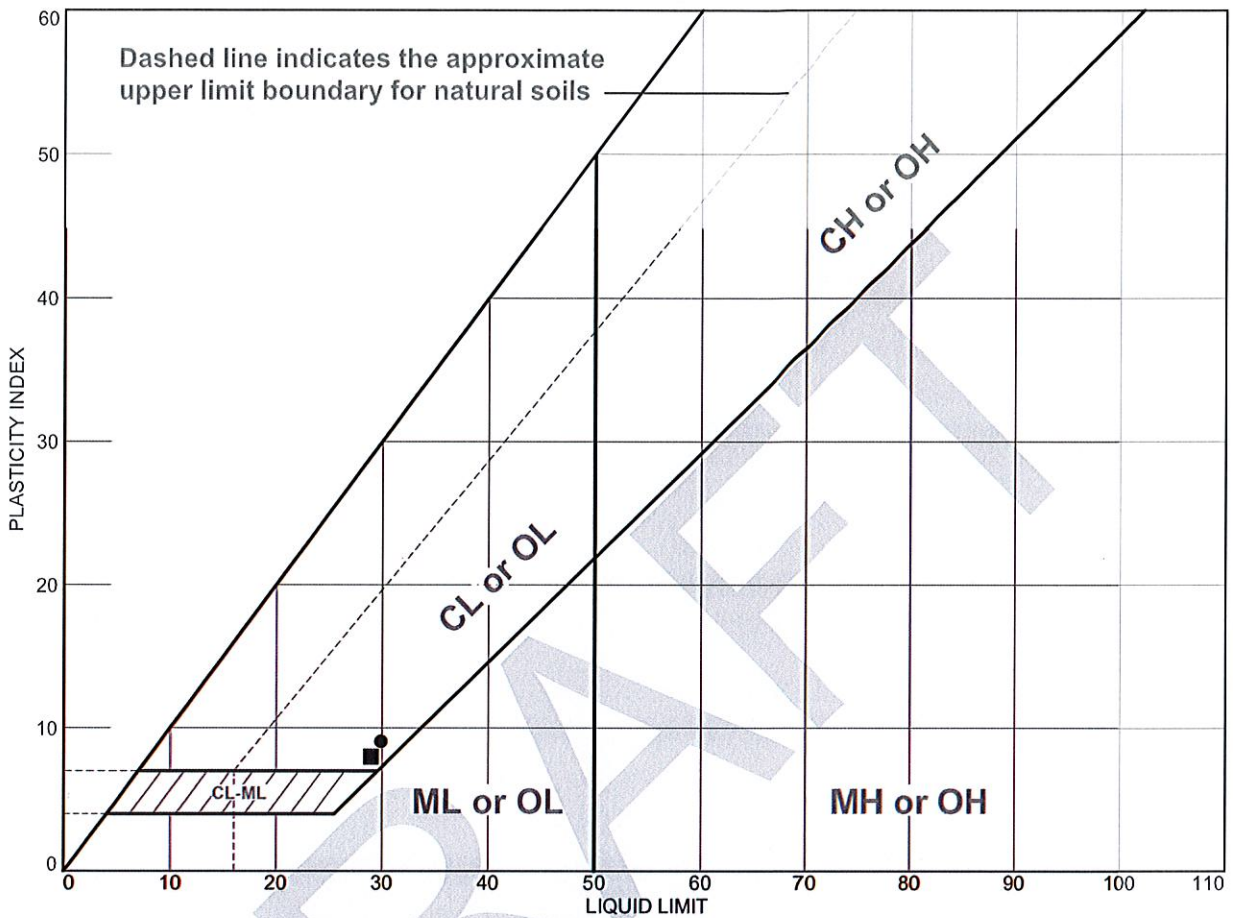
LIQUID AND PLASTIC LIMITS TEST REPORT

MATERIAL DESCRIPTION	LL	PL	PI	%<#40	%<#200	USCS
● Lean CLAY	30	21	9		99	CL
■ Lean CLAY	29	21	8		100	CL

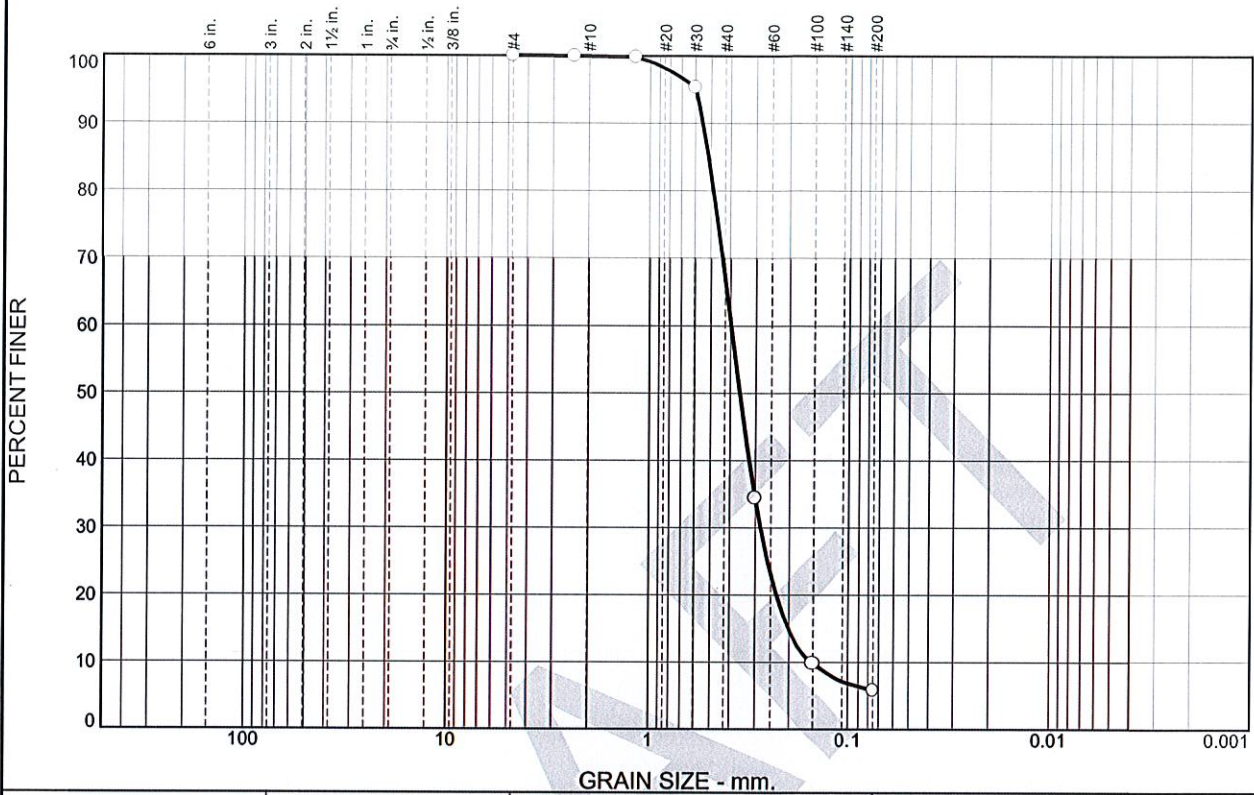
Particle Size Distribution Report

% +3"	% Gravel		% Sand			% Fines	
	Coarse	Fine	Coarse	Medium	Fine	Silt	Clay
0	0	0	0	33	61	6

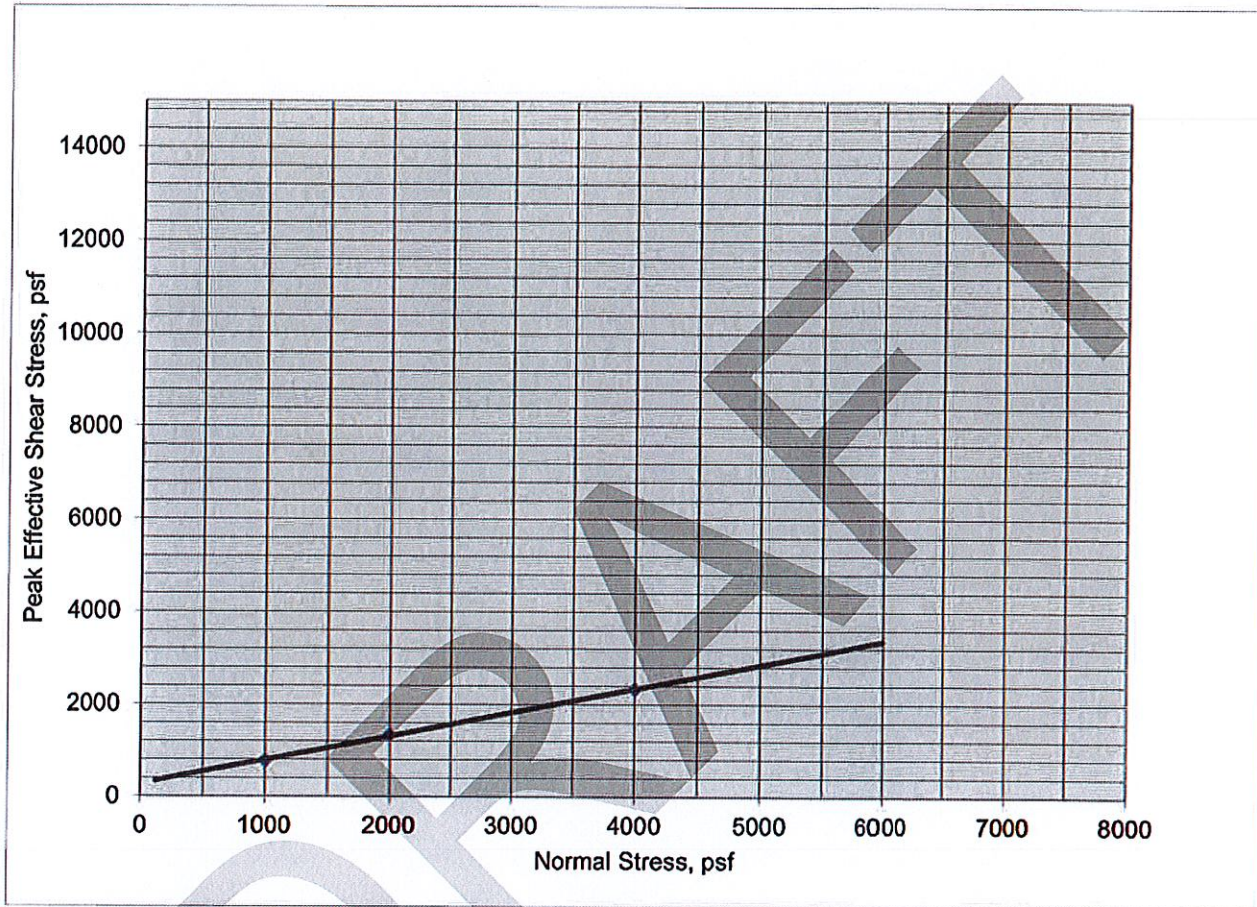
Project No.: 121-360G
Sample No.: S121-1080
Sample Location: B-2 @ 15.0'
Classification: Lean clay

Angle of Internal Friction (ϕ'):	<u>27</u>
Cohesion Intercept (psf):	<u>276</u>
Dry Unit Weight (pcf):	<u>105.9</u>
Water Content (%):	<u>22.8</u>
Shear Box Diameter (inches):	<u>2.4</u>
