**RESULTS OF ARCHAEOLOGICAL MONITORING AT THE PANHANDLE
SMELTING AND REFINING COMPANY SITE (10BR539), FOR THE PEND OREILLE
BAY TRAIL PROJECT, NEAR PONDERAY, IDAHO**

By Robert Lee Sappington and Laura L. Longstaff

12 December 2011

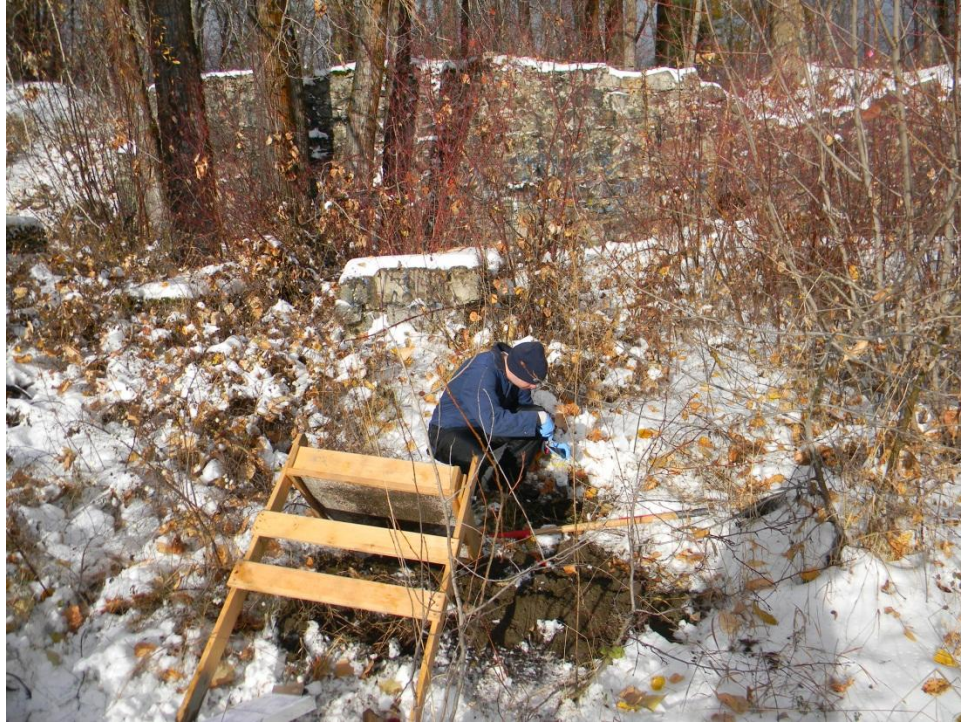
The first unit was excavated in the furnace area (Figure 4). This unit was located northwest of the blower and existing slag dump (“Black Rock”) and approximately 30 feet south of a portion of the remains of the smelter wall (Figure 5). The smelter wall runs in a north-east/south west direction. This unit was also located at a lower elevation than all other units. Excavation ended early at 18 in. (45 cm) BS due to a thick slag layer at that depth. Observed artifacts consisted of a round ceramic device (possibly an electrical conductor) and a brick fragment at 4 in. (10 cm) BS, and a large oval-shaped, metal ring at 12 in. (30 cm) BS (Figure 6). The first slag fragments were encountered at 18 in. (45 cm) BS and the thick slag layer prevented further excavation (Figure 7). The uppermost soil was a moist, dark brown loam that extended to 12 inches (30 cm) BS; the next stratum was a dry, light brown silt which continued until the slag layer at 18 inches (45 cm) BS. Due to the concentration of slag a second attempt for this unit was chosen that was situated ten feet northeast of the first location but this unit only reached 7 in. (18 cm) BS due to the predominance of large roots. No artifacts were encountered in the second location.

Figure 5. Photograph showing the location of Unit 1 (Z4-FU01-PS01, in the foreground) during excavation. Note the limestone smelter wall in the background. The view is to the northwest.

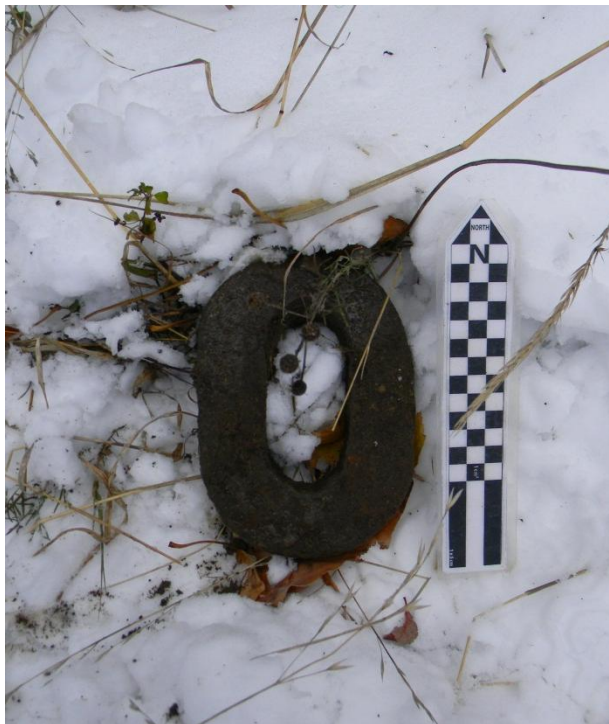
Figure 6. Photograph of the large, oval-shaped, metal ring found at 12 inches (30 cm) BS in Unit 1. Note that the scale is 20 cm (8. in) long and is the same in all photographs.

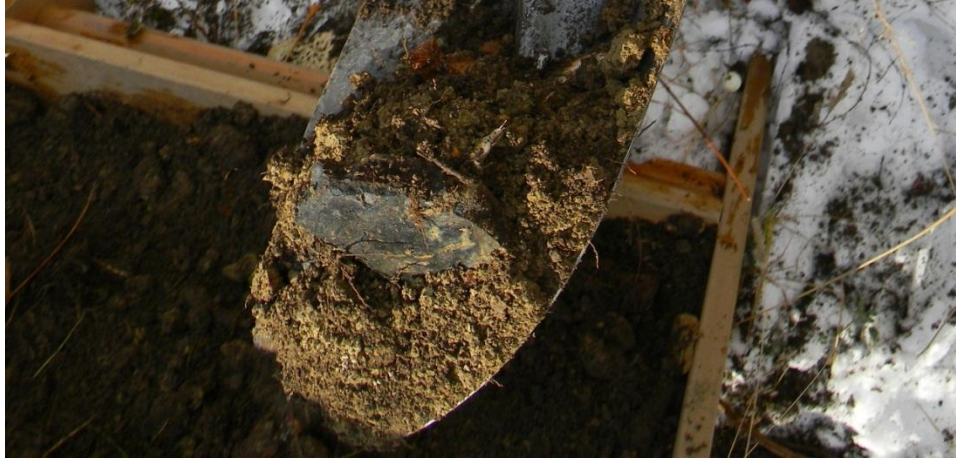
Figure 7. Close-up photograph showing a fragment of the slag encountered at 18 in. (45 cm) BS in Unit 1.

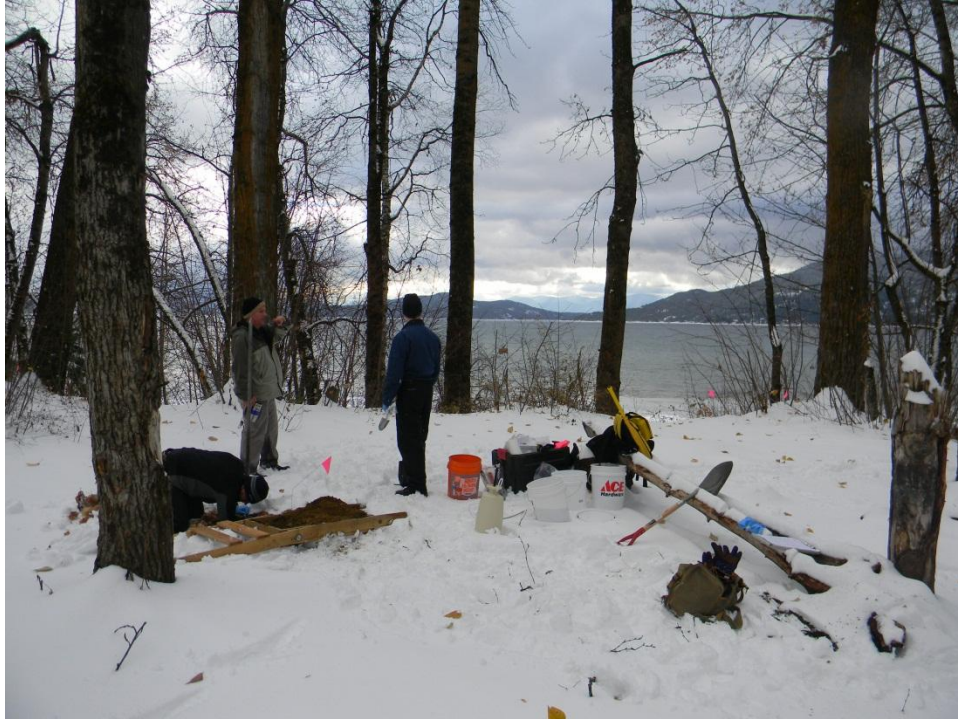
The second unit was located approximately 120 feet north and slightly west from the first unit in the landing area of the smelter facility and on a flat terrace elevated about 10 feet above the smelter wall (Figure 4). A modern campfire feature was also located here along with a horizontally raised wooden post which is likely used as a bench. The fire pit was covered with snow (Figure 8). This unit was excavated to 24 in. (60 cm) BS. Artifacts encountered in this unit were limited to the top 12 in. (30 cm) and consisted of limestone fragments, a round metal can fragment measuring 3 cm in diameter, a railroad spike measuring 15 cm in length, one colorless vessel glass fragment, one brown vessel glass fragment, and one nail measuring 2 in. (5 cm) in length. The same top soil layer of moist, dark brown loam encountered in Unit 1 was also present in the upper part of this unit but it was quickly replaced by yellow and reddish discolored soil (Figure 9) at 4 in. (10 cm) BS. The discolored soil extended to a depth of 16 in. (40 cm) BS where it was replaced by a light gray silty clay that continued to the bottom of the unit.

Figure 8. Photograph showing the location of Unit 2 (Z4-LA02-PS01, at left center). A soil sample is being taken from the bottom of the unit. The modern wooden post can be seen at the right. The view is to the southeast.

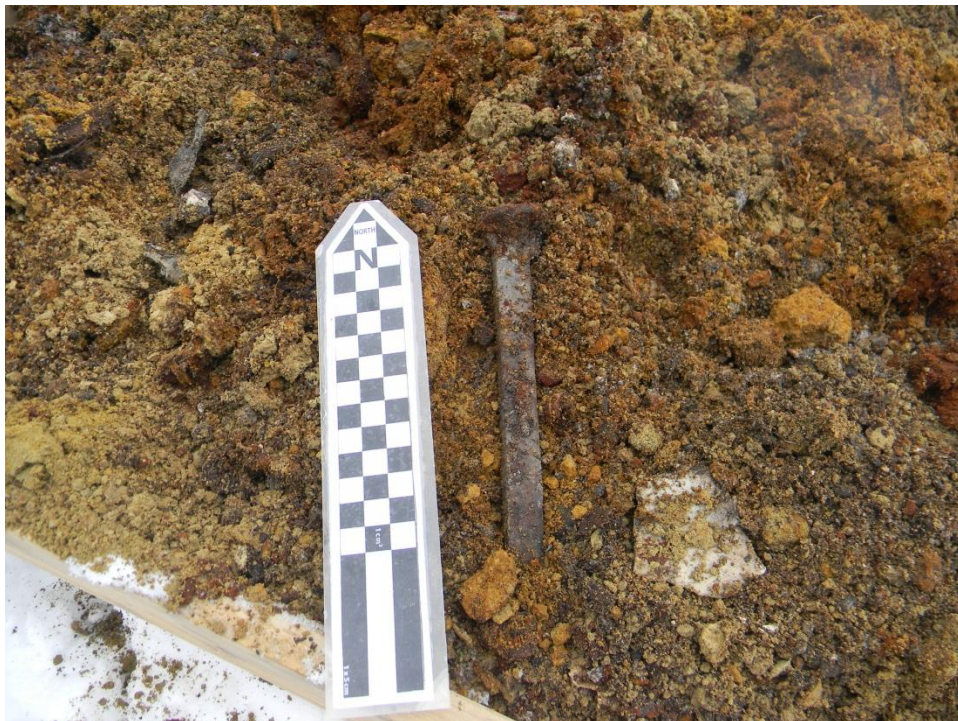
Figure 9. Photograph showing the discolored soil in the screen from the top 12 in. (30 cm) of Unit 2; note the railroad spike (center) and limestone fragment (center right).

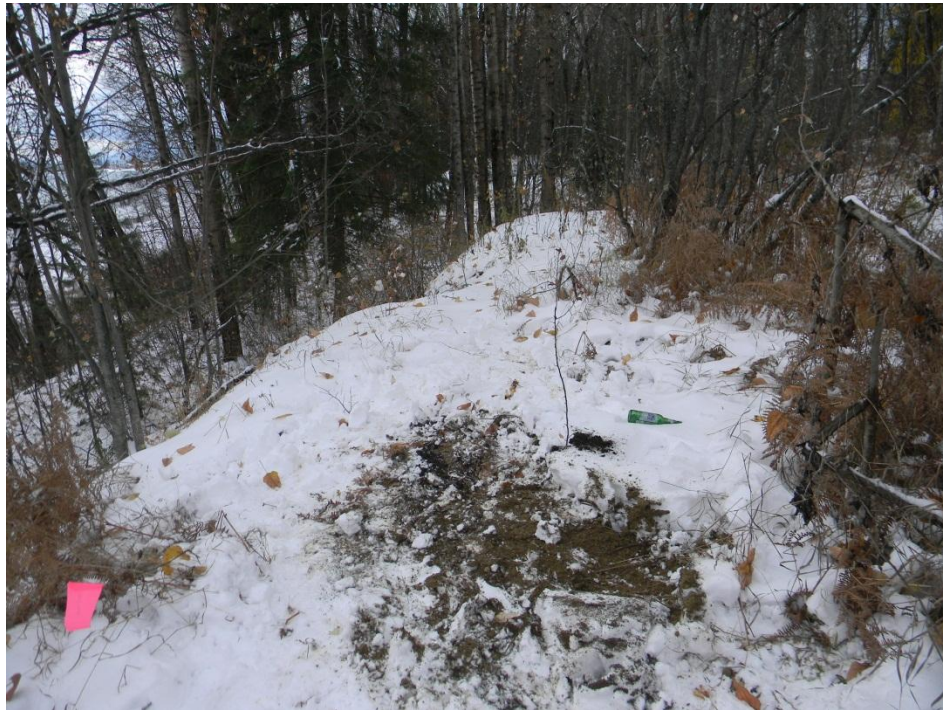
The third unit was located approximately 190 feet northeast of the previous unit in the stack area of the smelter facility on an elevated slope approximately 10 feet above the modern campfire. Artifacts were limited to the upper 18 in. (45 cm) and included only one modern green glass Rolling Rock beer bottle at 2 in. (5 cm) BS and slag fragments at 18 in. (45 cm) BS. The slag material was similar in composition to that encountered in Unit 1 and it occurred at the same depth. The top layer of soil consisted of moist, dark brown loam that extended to 18 in. (45 cm) BS. Dry, light brown silt occurred with the slag fragments at 18 in. (45 cm) BS and this layer was replaced by the light gray silty clay which continued to the completion of the unit at 24 in. (61 cm) BS.

Figure 10. Photograph showing the location of Unit 3 (Z4-ST01-PS01). The modern rail line terrace can be seen at the top left behind the trees. The modern Rolling Rock beer bottle from 2 in. (5 cm) BS is adjacent to the unit which has been backfilled. The view is to the north.

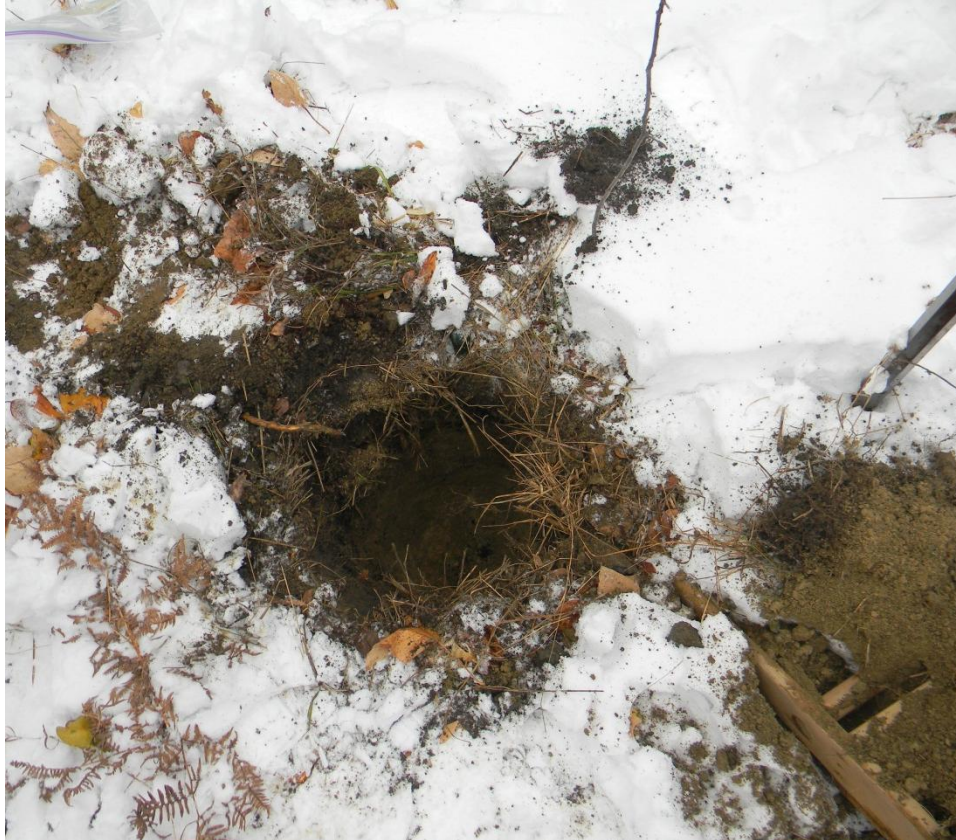
Figure 11. Photograph of Unit 3 (Z4-ST01-PS01). Excavation has been completed at 24 in. (60 cm) BS.

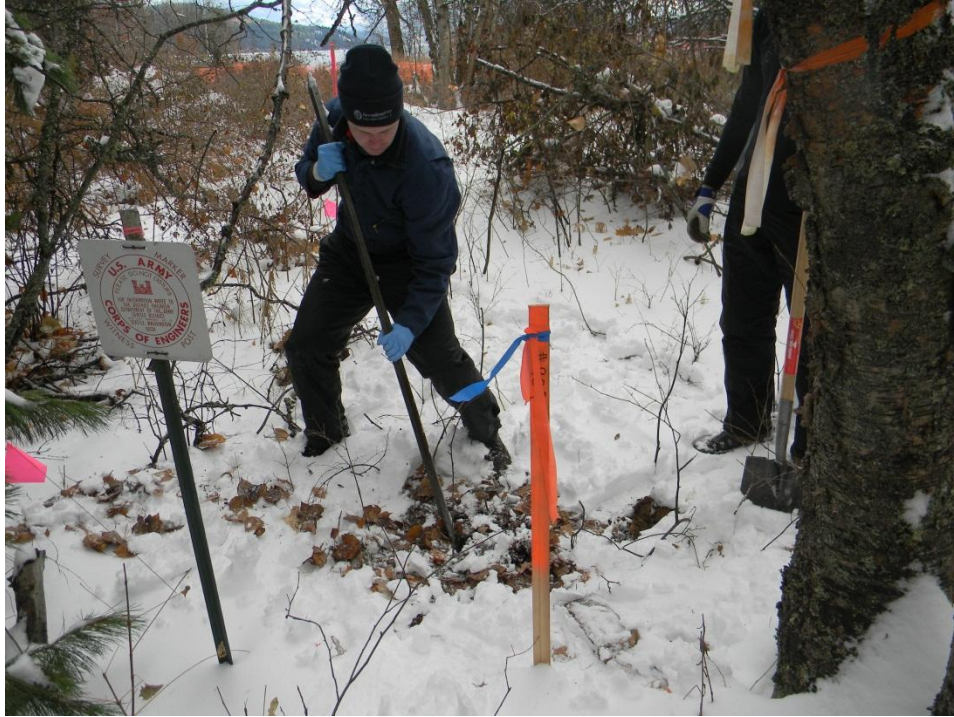
The fourth unit was located approximately 130 feet north, and slightly west of, the previous unit and north of the boundary of the roasters area of the smelter facility. This unit was also located a few feet away from a U. S. Army Corps of Engineers survey marker (Figure 9). The three roaster mounds could be seen from this location (Figure 9). No artifacts were encountered in this unit. Moist, dark brown loam was present in the top 12 in. (30 cm); at that point it was replaced by a reddish brown soil that continued until 18 in. (45 cm) BS where a light gray silt clay was encountered; the light gray silt clay continued to the completion of the unit at 24 in. (60 cm) BS.

Figure 12. Photograph of Unit 4 (Z4-RO03-PS01) at the beginning of excavation. The person is loosening the soil with a stake in preparation to excavate with the shovel. Lake Pend Oreille can be seen distantly in the top left behind the trees. The view is to the southeast.

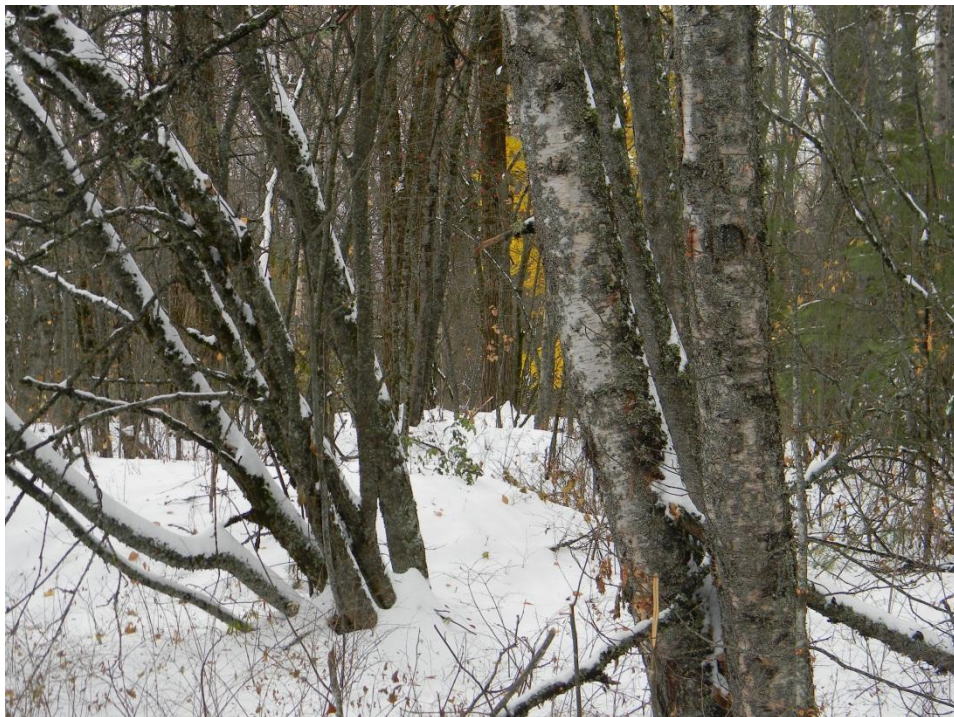
Figure 13. Looking southwest from Unit 4 (Z4-RO03-PS01). Note the snow-covered roaster mounds between the trees.

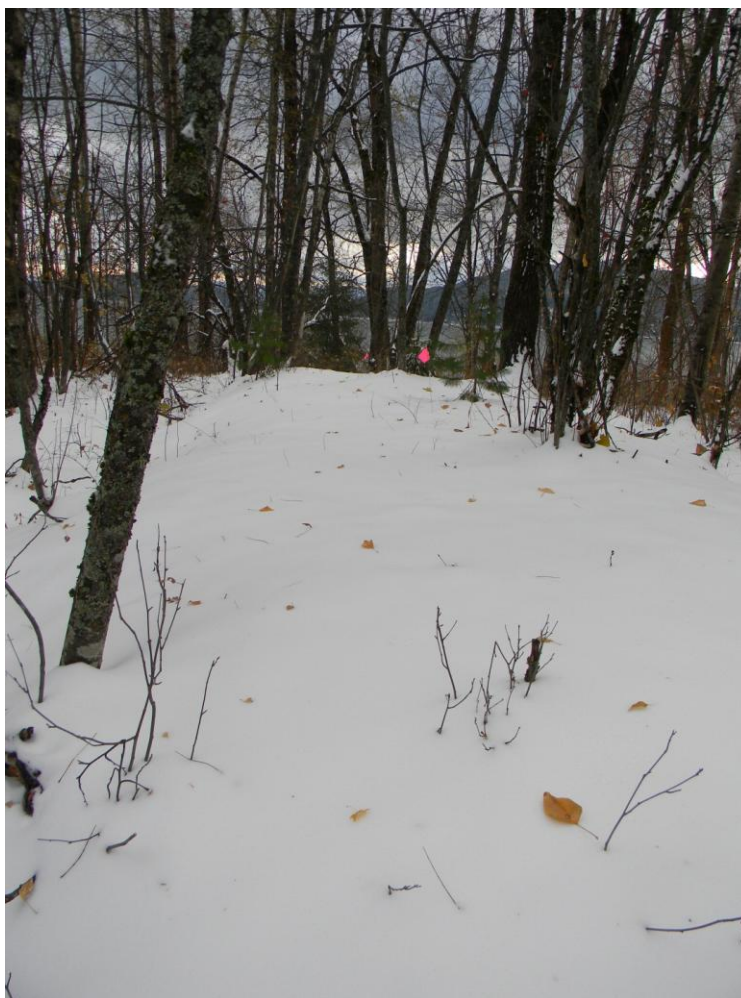
The fifth unit was located within the roaster area ca. 140 feet southeast of the previous unit and on top of the westernmost roaster mound (Figure 14). These roasters were used to heat the raw ore brought to the site and the sediment and materials which they contained were thought to be extremely contaminated. They have caved in and been covered with a thin layer of topsoil. Burned bricks, both fragmented and intact, were the only type of artifact encountered in this unit and these occurred simultaneously with thick ash deposits. Brick size and frequency, as well as ash concentrations, increased in volume as the depth increased. The topsoil, consisting of moist, dark brown loam occurred only in the top 2 in. (5 cm) BS; it was replaced by a loam mixed with thick gray ash deposits to a depth of 6 in. (15 cm) BS (Figure 15). From 6 to 20 in. (15-50 cm) BS there was little to no soil and the gray ash occurred uniformly (Figure 16). The remaining stratum contained the highest amount of intact large bricks and it consisted predominantly of ash and rust-colored deposits with very little to no soil (Figure 17). This stratum continued to the completion of the unit at 24 in. (61 cm) BS.

Figure 14. Photograph showing the location of Unit 5 (Z4-RO02-PS01) which is indicated by the pink flag. Lake Pend Oreille can be seen beyond the trees. The view is to the southeast.

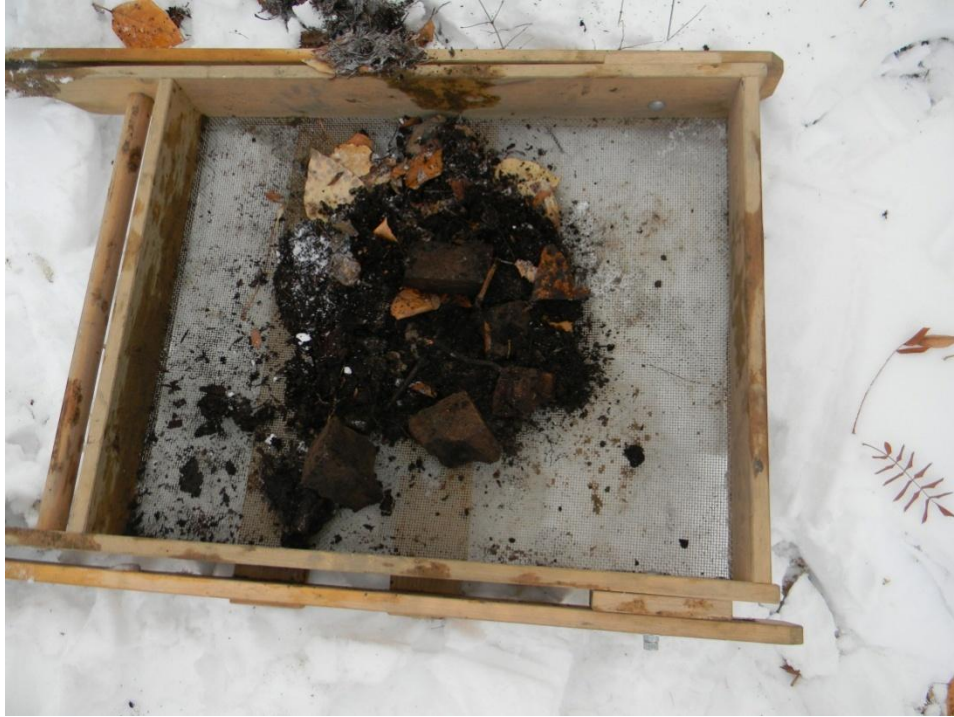
Figure 15. Photograph showing sediment from the top 6 in. (15 cm) in Unit 5. The dark topsoil can be seen below the burned brick fragments.

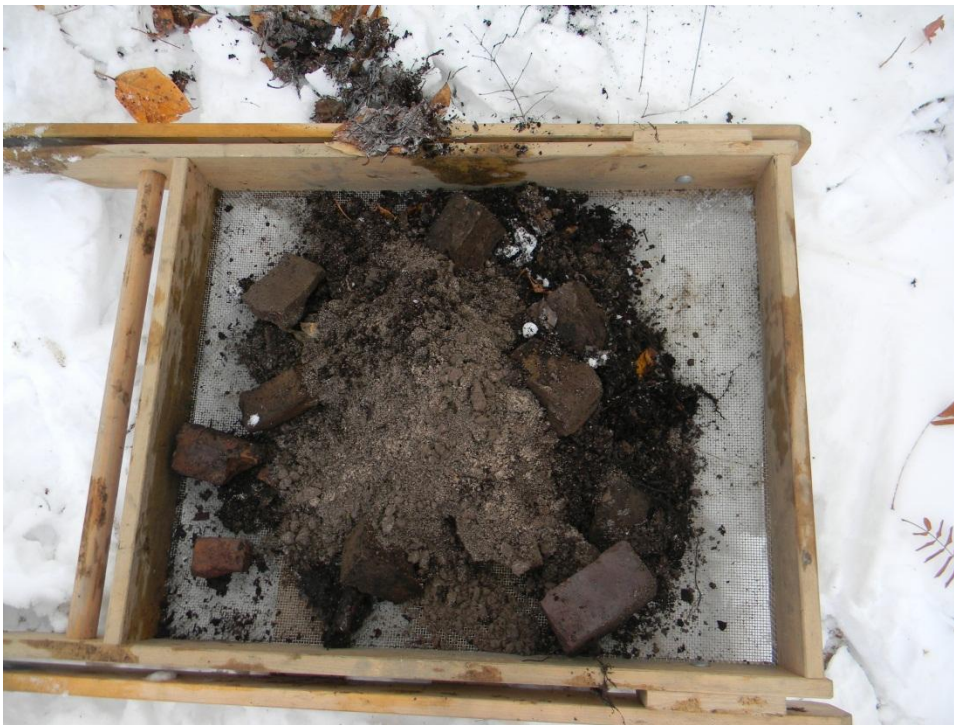
Figure 16. Photograph showing sediment from the top 8 in. (20 cm) in Unit 5. The ash and dark loam mixture can be seen below the first occurrence of the thick ash. Note that intact and larger bricks are beginning to occur.

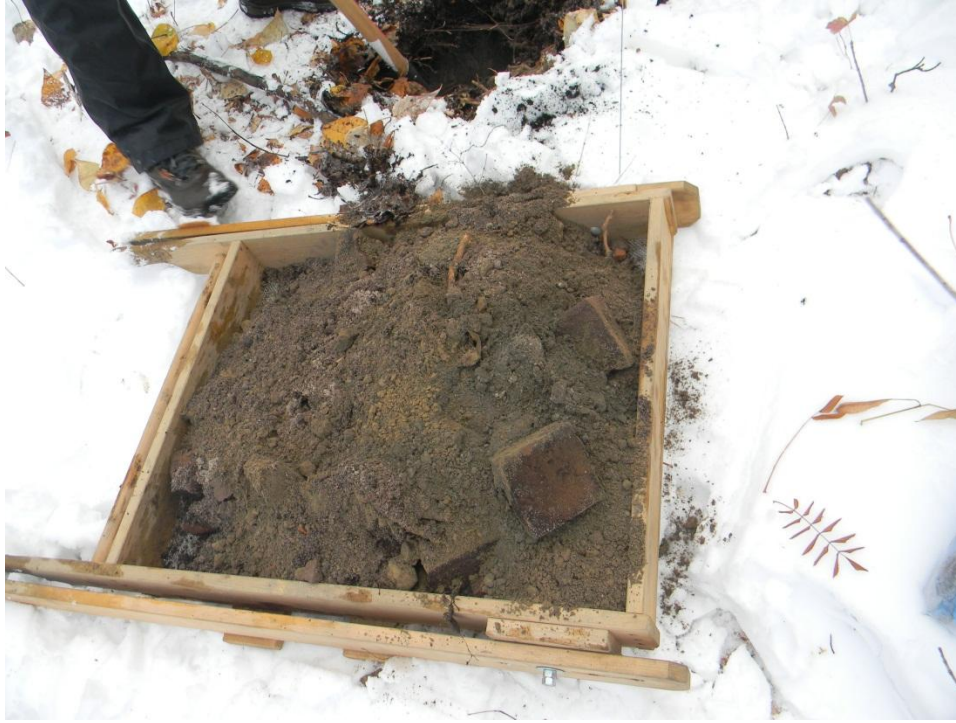
Figure 17. Photograph showing sediment from the bottom layer in Unit 5. Note that the ash in the screen from a depth of 20 in. (50 cm) also contains oxidized sediment and larger bricks.

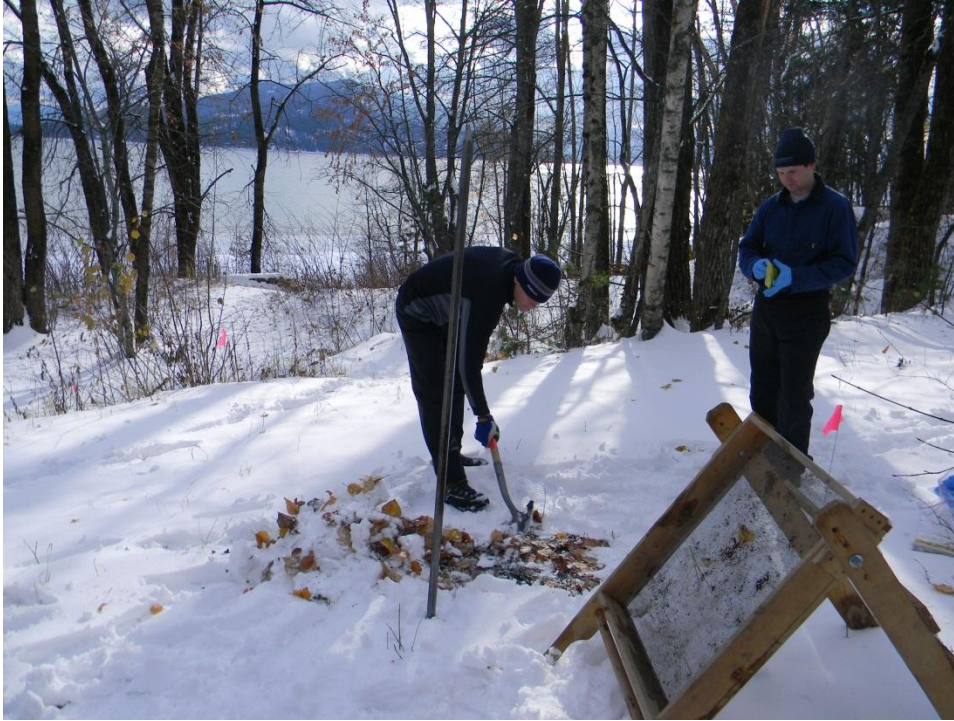
The sixth unit was located approximately 90 feet southwest of the previous unit, and approximately 75 feet southeast of a rail line used for transporting ore within the area of the smelter facility (Figure 18). Slag fragments occurred between 8 and 20 in. (20 and 50 cm) BS and this was the only cultural material observed. The slag fragments from this unit were larger, denser, and more coarsely-grained than the material observed in the first and third units (Figure 19). This may represent different ore processing methods and the transportation of such ore by the nearby rail line. The moist, dark brown loam was present in the top 8 in. (20 cm) of this unit. A yellow-brown discoloration occurred with the appearance of the slag fragments from 8 to 20 in. (20-50 cm) BS; at that depth it was replaced by the light gray silt clay which continued to the completion of the unit at 24 in. (60 cm) BS.

Figure 18. Photograph showing the location of Unit 6 (Z4-RL01-PS01). The person is clearing the surface in preparation for excavation. The view is to the south.

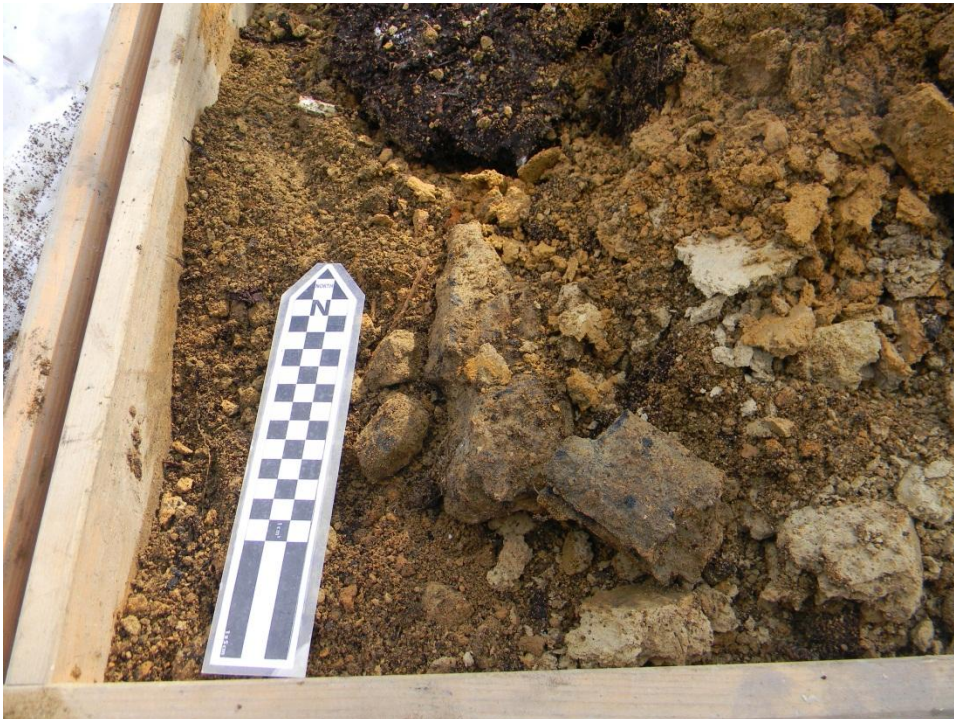
Figure 19. Photograph of sediment from Unit 6. The first slag fragments in the screen were associated with the yellow-brown discolored soil from 8 in. (20 cm) BS.

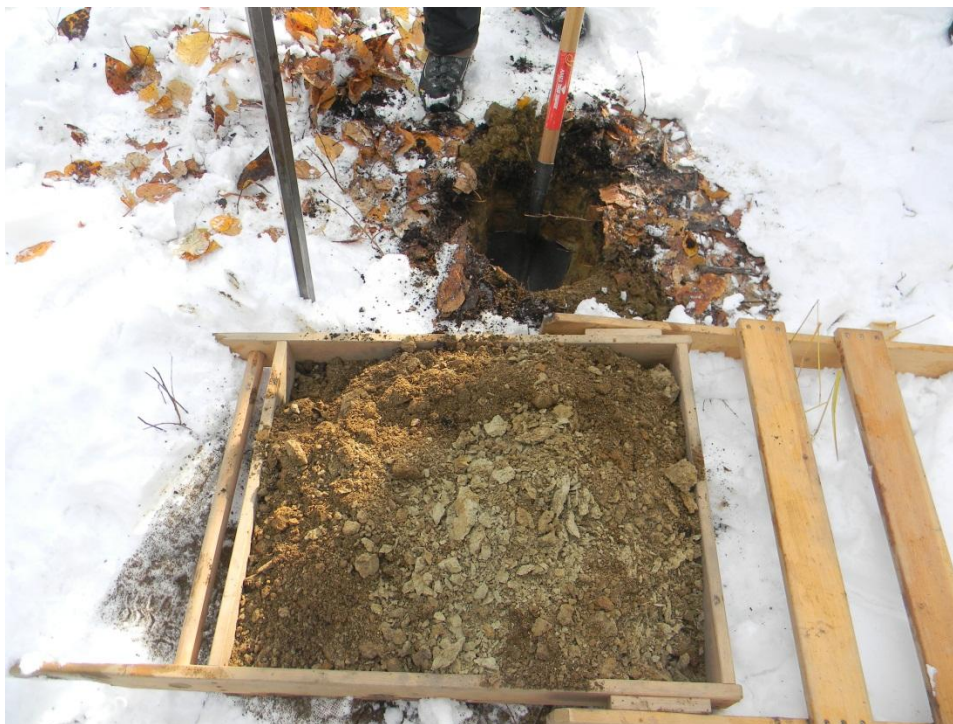
Figure 20. Photograph showing sediment from Unit 6 during excavation. Note the gray silt clay on top of the screen which is beginning to appear at 20 in. (50 cm) BS.

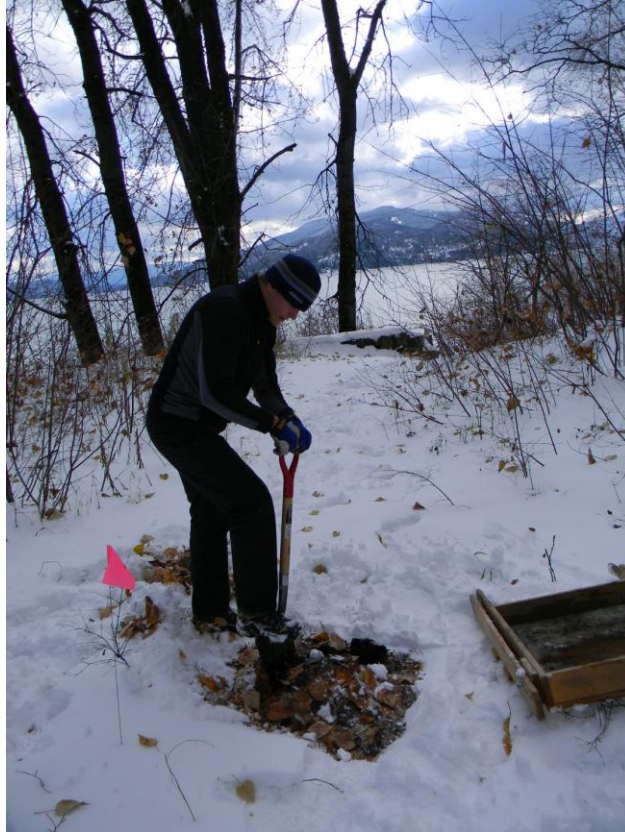
The eighth and final unit was located approximately 120 feet west of the previous unit in the southern landing area of the smelter facility (Figure 21). The only cultural material encountered in this unit was one fragment of limestone, similar to the fragments in Unit 2 (Z4-LA02-PS01), and it occurred at 8 in. (20 cm) BS. Moist, dark brown loam was present in the top 8 in. (20 cm) and it was replaced with the light gray silt clay which continued to the completion of the unit at 24 in. (61 cm) BS. The silt clay occurred earlier in this unit than in any others.

Figure 21. Photograph showing the location of Unit 8 (Z4-LA01-PS01). The person is beginning to remove the top of the soil. The view is toward the southeast.

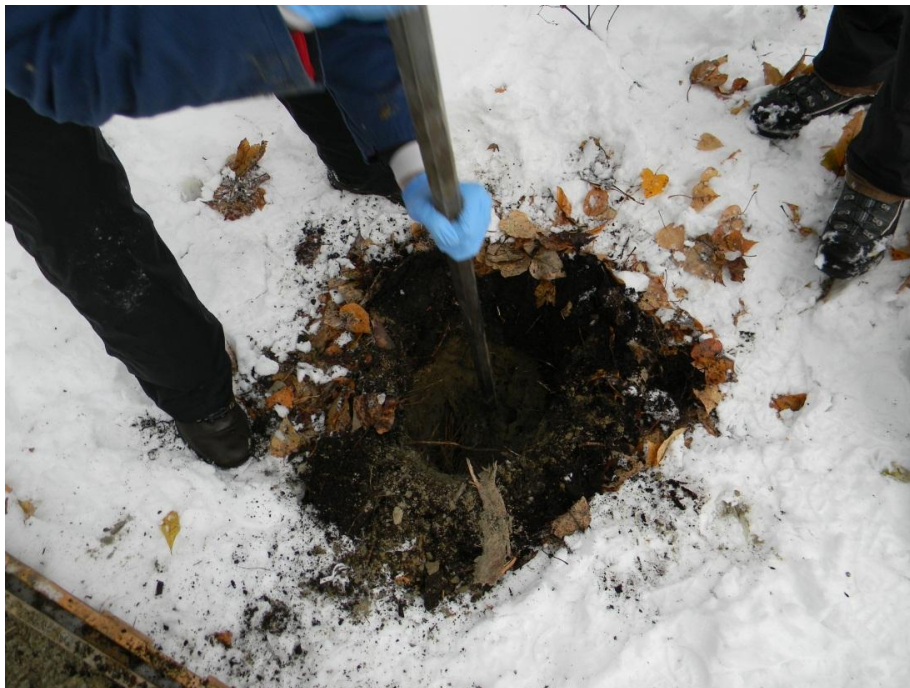
Figure 22. Photograph of Unit 8 nearing completion at 24 in. (61 cm) BS; the stratum of gray clay can be seen clearly as it begins to appear at 20 cm BS.

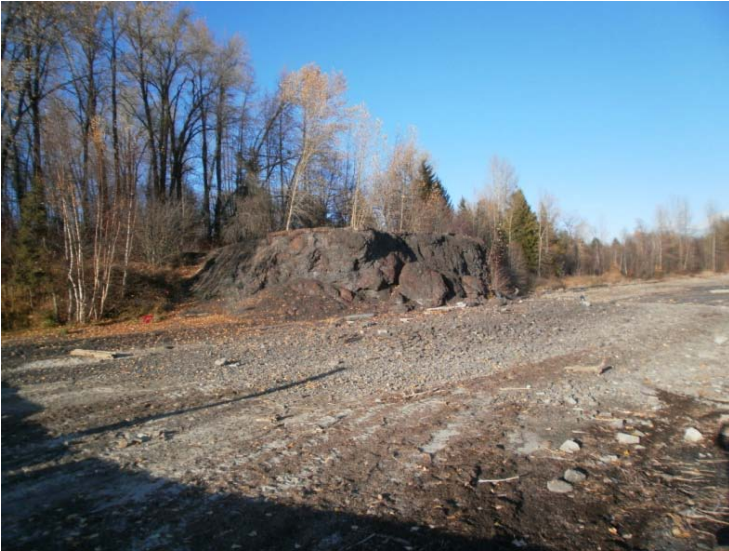
Photo 1: Beach area in front of slag pile: mix of sand, rock, and slag.

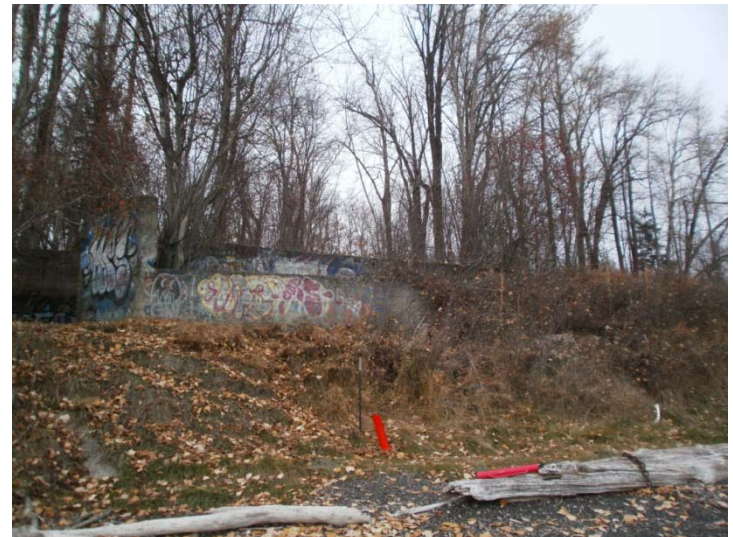
Photo 4: “Black Rock” west of slag pile: contains cement foundation of former power plant.

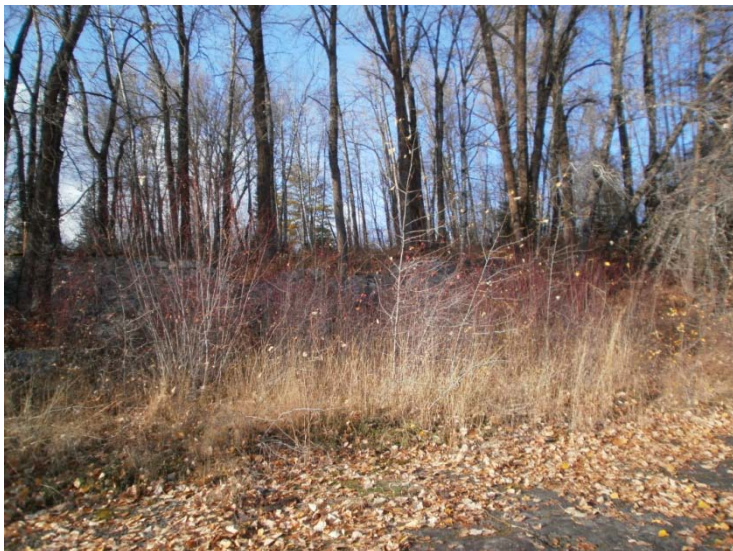
Photo 7: Former blast furnace area: cement floor below soil in some parts.

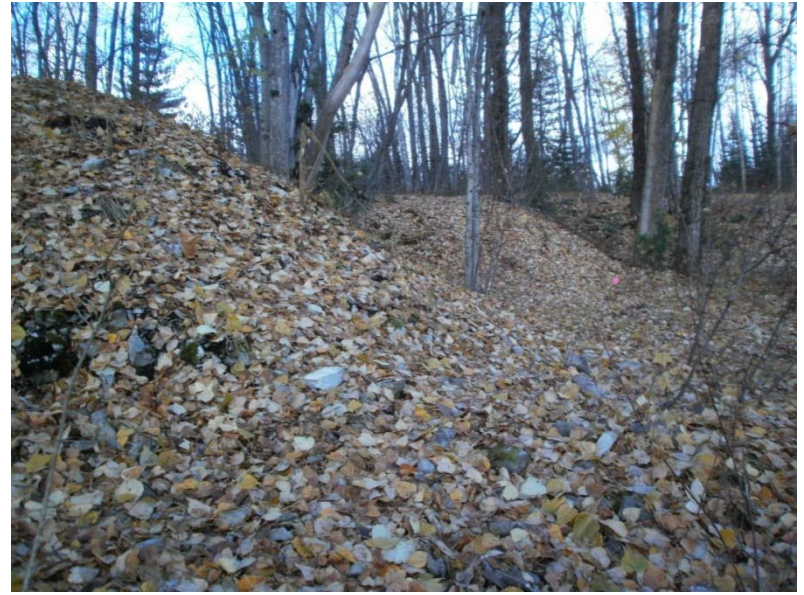
Photo 17: Pile (likely ore) covered by soil and leaf litter.

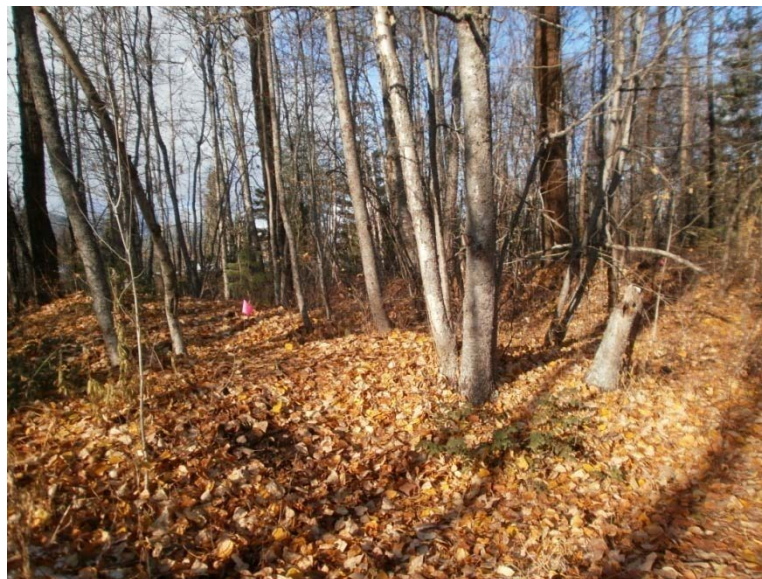
Photo 22: Three mounds in former roasters area.

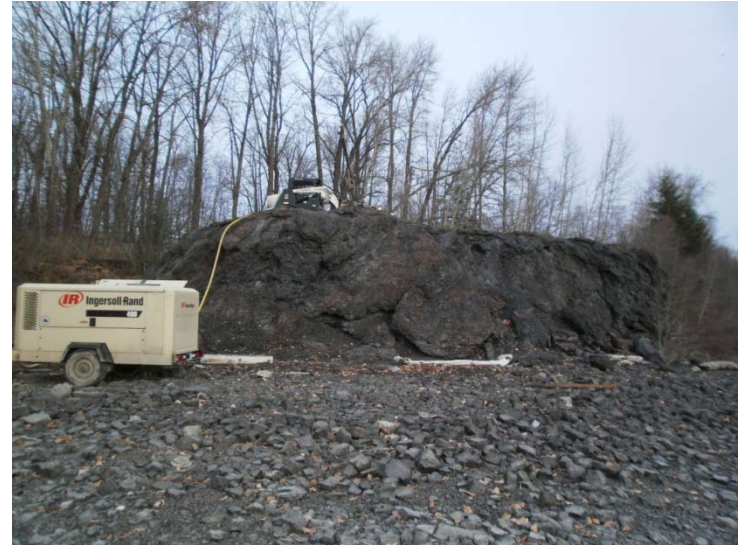
Photo 38: Slag pile outcrop showing the approximate height above the beach.

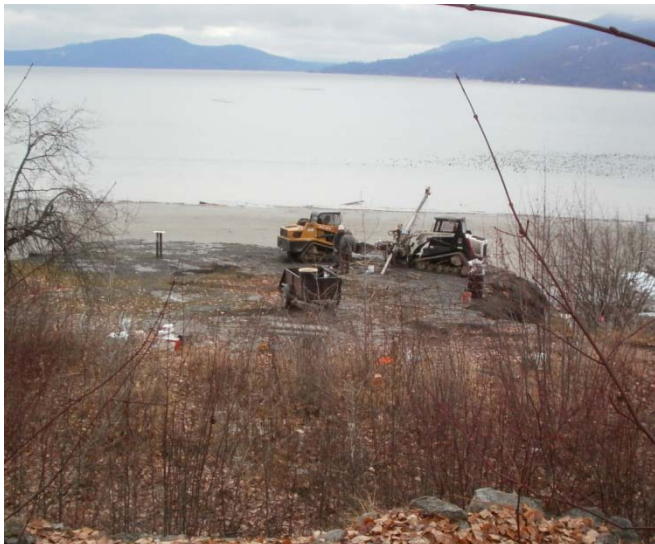
Photo 39: Air Rotary drill mounted to a track-operated skid steer .
