# City of Ponderay, Idaho

## Stormwater Masterplan Report and Recommendations

Submitted: May 16, 2005

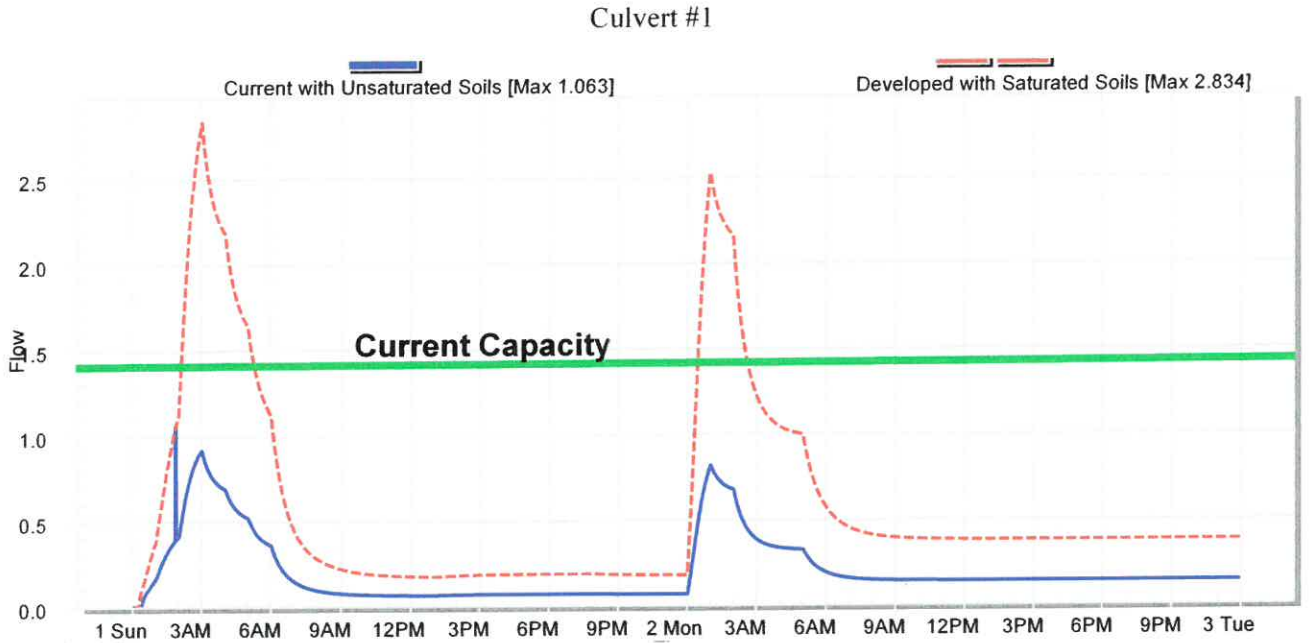
The ITD Basin is approximately 93 acres in size, and extends southeast from Triangle Drive to the outfall at the lake. Culvert 1 at Triangle Drive is 12" in diameter and has a damaged inlet. The culvert is undersized for the simulated event when the land becomes developed in the future. At this time, the estimated peak flow will be 3 cfs, which is well over the current 1.5 cfs capacity of the pipe. This will cause flooding of the ditch lines and saturation of the road base. The flow moves from culvert 1 into an open channel and downstream into a shallow detention area at the inlet of culvert 2. It would be beneficial to increase the capacity of this pond and upstream channel to provide additional treatment and storage. If the land is developed and this storage capacity removed, the downstream culverts (2-6) would all need to be enlarged. As it is, culverts 2-6 are all near capacity for the simulated storm after full land development has occurred. The drainage continues under the UPRR tracks and HWY 200 into a channel alongside the ITD offices. The channel has accumulated an excessive amount of sediment, causing adverse outlet conditions for culverts 3 and 4.

Replace culvert 1 with a pipe arch capable of passing 3 cfs. From the Handbook of Steel Drainage and Highway Construction Products (Table 3.15) a 17 x 13 arch would be adequate for the flow.

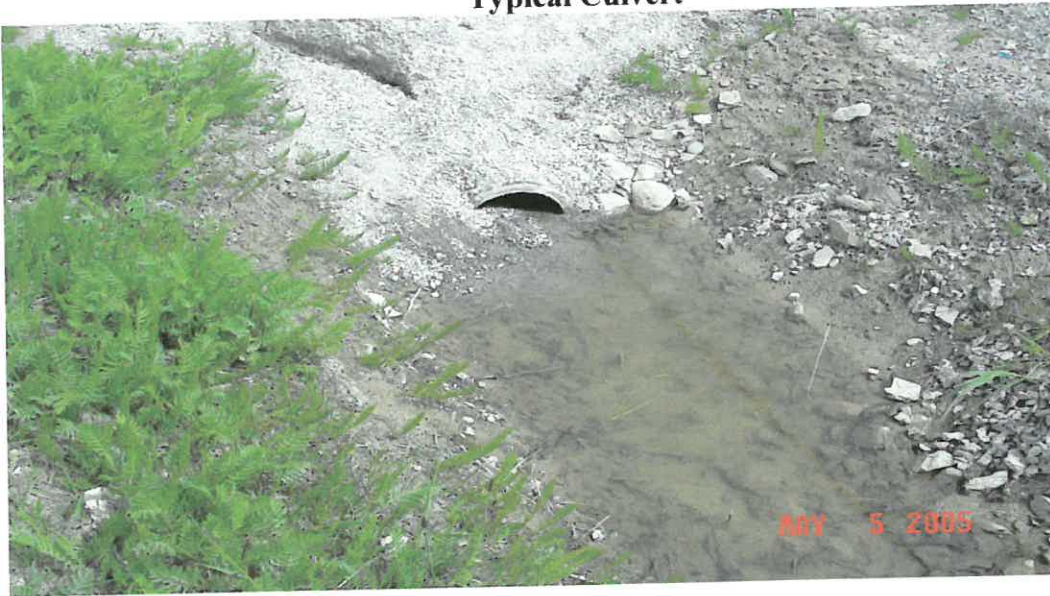
**Typical Culvert**

The McNearney Road Basin is approximately 163 acres in size and extends south along McNearney Road, crosses Kootenai Cutoff Road and HWY 200 and flows into the lake. The ditch lines along McNearney Road are undersized, and many of the culverts are plugged with debris. As a result, saturation of the road base and surrounding land occurs during large storm events. The runoff crosses Kootenai Cutoff Road and enters a natural channel that flows into a shallow detention area north and west of culvert 15. In the past several years, two new apartment complexes have been built on the land to the north of this detention area. The detention storage specified in the stormwater plans for the two developments was never created, and flooding of the area occurs north of culvert 15. The runoff then flows south under the UPRR tracks and HWY 200 through culverts 15, 16, and 17. Culvert 15 (24" dia) has a tree obstructing the outlet and a minimal slope which reduce its flow capacity to about 8 cfs. This creates flooding of the upstream detention area during major runoff events. Culvert 16 (18" diameter) is also under capacity, which causes flooding alongside HWY 200 and saturation of the road base. The rest of the system has adequate capacity for the design storm.

- Clean and widen ditch lines to create grassy swale treatment and storage areas.
- Remove debris from culverts.
- Divert flow off the northern half of McNearney Road into the Coldwater Creek Basin. This would require that the recommended changes be made to the Coldwater Creek Basin.

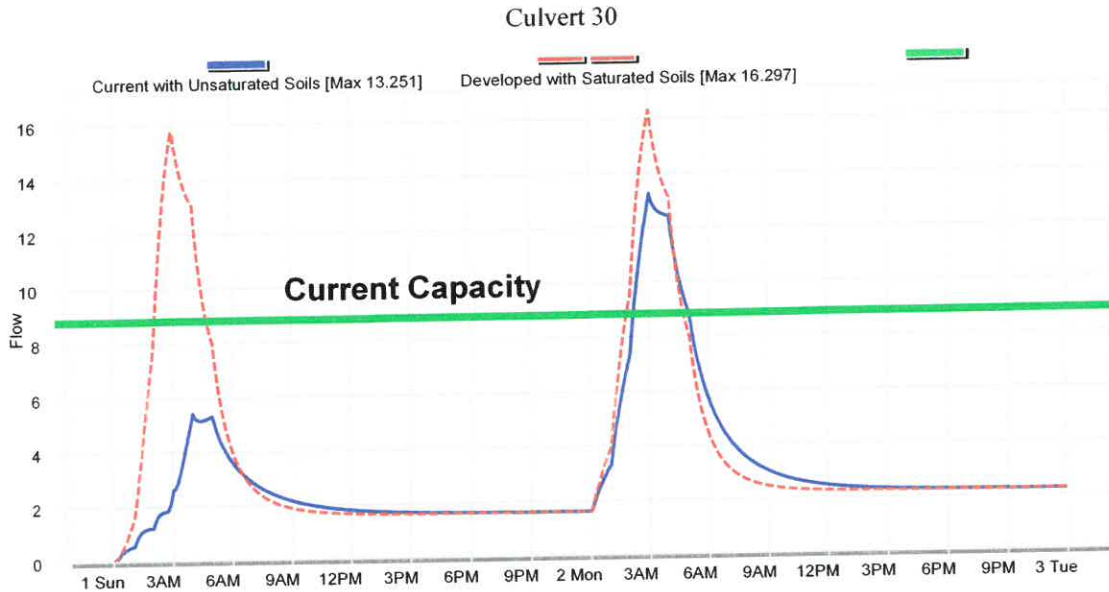
**Culvert 30 Outlet**

The eastern drainage has several areas that need improvement. First, culvert 30 (30" dia) under the UPRR tracks has an outlet set 2 feet below the elevation of the downstream channel. This creates adverse outlet conditions, and reduces the capacity of the culvert from about 30 cfs to 9 cfs. The reduced capacity causes flooding of the trailer park and areas on the north side of the tracks. Second, culvert 31 (36" dia) passing under HWY 200 has been shown both by observation and in the model to have severe flooding at the upstream end. Theoretically, the culvert should pass the 25 cfs flow that results from the design storm. However, an inspection of the culvert reveals a low point in the middle of the highway, sediment buildup at the outlet, and a constriction in the downstream channel. These conditions reduce the culvert capacity from 35 cfs to approximately 14 cfs. Third, the channel immediately downstream of culvert 31 is undersized and has two 90 degree bends that create turbulent flows and excessive erosion. The remainder of the drainage south of HWY 200 has debris buildup and a highly erodeable channel. The grate on the vertical pipe inlet of culvert 37 (48" dia) was found to be plugged with debris.

- Raise the outlet of culvert 30 by 2 feet in order to increase the capacity of the culvert to 30 cfs (currently 4' fall from inlet to outlet).

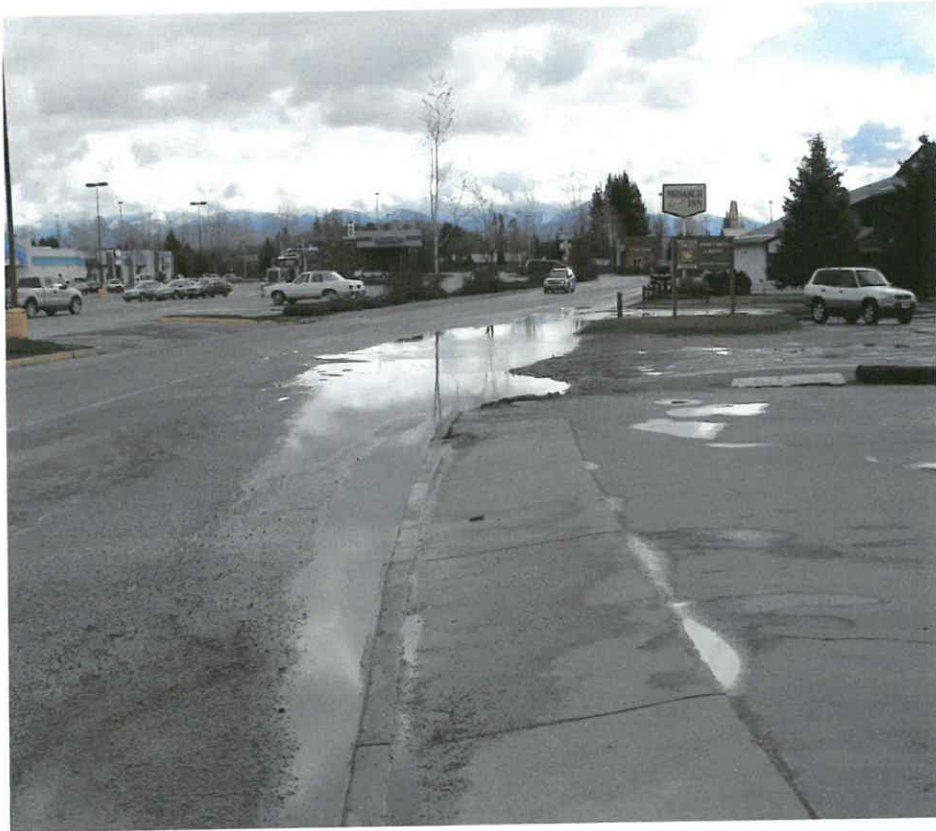
The Bonner Mall/Fontaine Drive Basin is approximately 56 acres in size with the UPRR tracks and Triangle Drive forming the eastern boundary. A storm drainage system associated with the Bonner Mall and surrounding businesses collects the runoff in catch basins. A low area on the south side of Bonner Mall Road in front of Les Schwab prevents runoff from entering a catch basin, and the road has long periods where standing water saturates the road section. During inspection of the basins, some were found to have excessive sediment buildup. A lift station is used to move the runoff from the east side of the Bonner Mall to the west side. The runoff then flows through a series of storm pipes and catch basins and into a wetland east of Fontaine Drive. Over the years, this wetland has filled with sediment and debris, and the outlet culvert could not be located during this study. However, the water is able to find the outlet, and the flow moves through a culvert under Fontaine Drive and into a wetland on the east side of HWY 95. The runoff then crosses HWY 95 and is deposited into Sand Creek.

- Install a catch basin at the low area on the south side of Bonner Mall Road and use a storm pipe to drain the runoff to a catch basin behind the Monarch Inn.

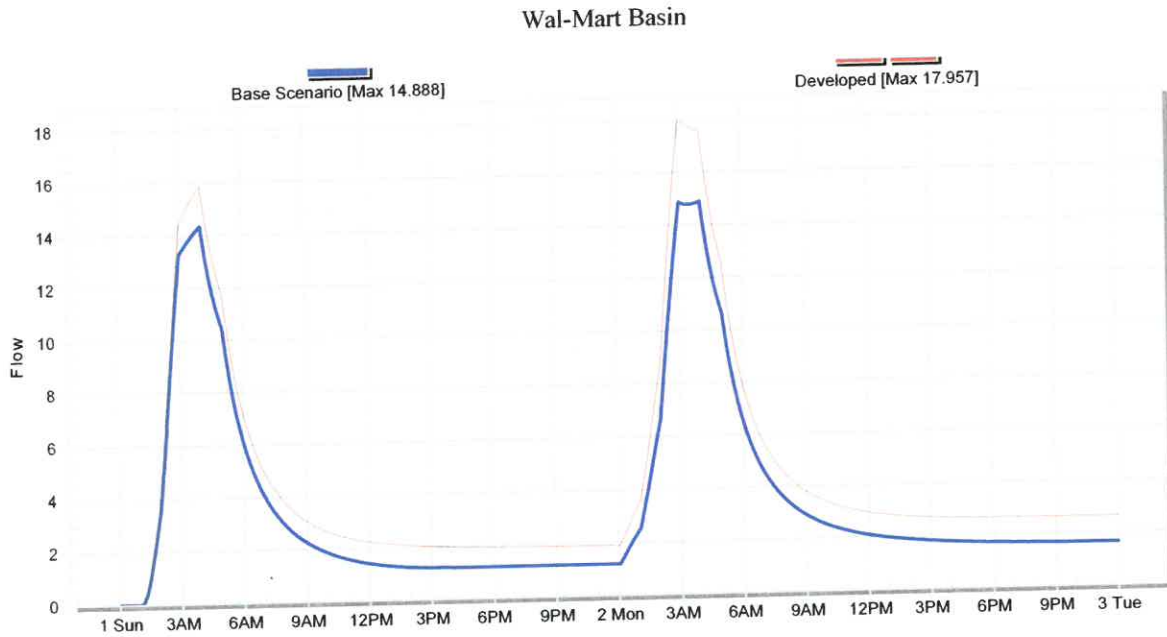
The Wal-Mart Basin is approximately 91 acres in size. The drainage flows south along the east side of Starr Lane, and west down Kootenai Cutoff Road. The runoff from Home Depot and Wal-Mart join the drainage before the flow crosses HWY 95 and enters Sand Creek. The ditch lines along Starr Lane are too shallow, narrow, and have a minimal slope. As a result, saturation of the road base occurs. The rest of the storm drainage is in good condition.

- Saturated Road Base  
Enlarge and deepen existing ditch lines along Starr Lane to create grassy swales that will provide treatment and reduce saturation of the road base.

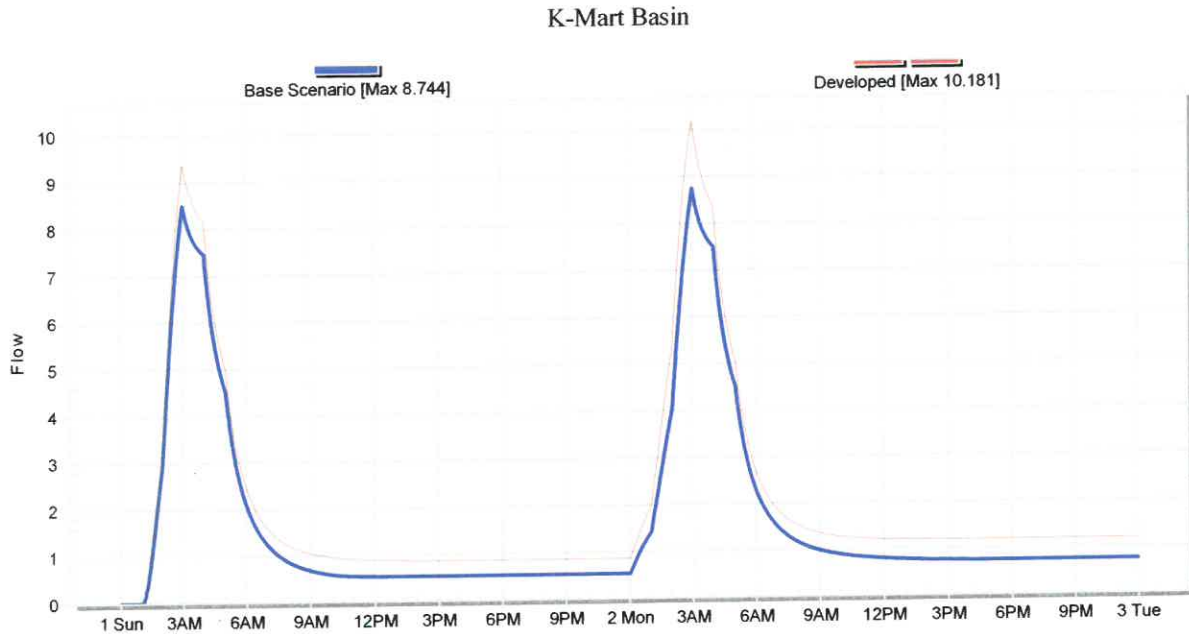
The K-Mart Basin is approximately 41 acres in size. It drains the northern half of Starr Lane, Piehl Road, and the old K-Mart property before crossing HWY 95 and entering Sand Creek. The ditch lines along Starr Lane and Piehl Road are too shallow, narrow, and have a minimal slope. This leads to saturation of the road base during any significant storm event. In addition, the runoff from the K-Mart property does not have on-site treatment.

- **Saturated Road Base**  
Enlarge and deepen existing ditch lines along Starr Lane to create grassy swales that will provide treatment and reduce saturation of the road base.
- **Storage and Treatment**  
Create grassy swale treatment areas for the runoff from the K-Mart property.
